NOTICE TO OPERATORS BR700-710A2-20 ENGINES

NTO No.: 87

TITLE: Troubleshooting in case of ITT cross-check failure

EFFECTIVITY: ALL BR700-710A2-20 ENGINES

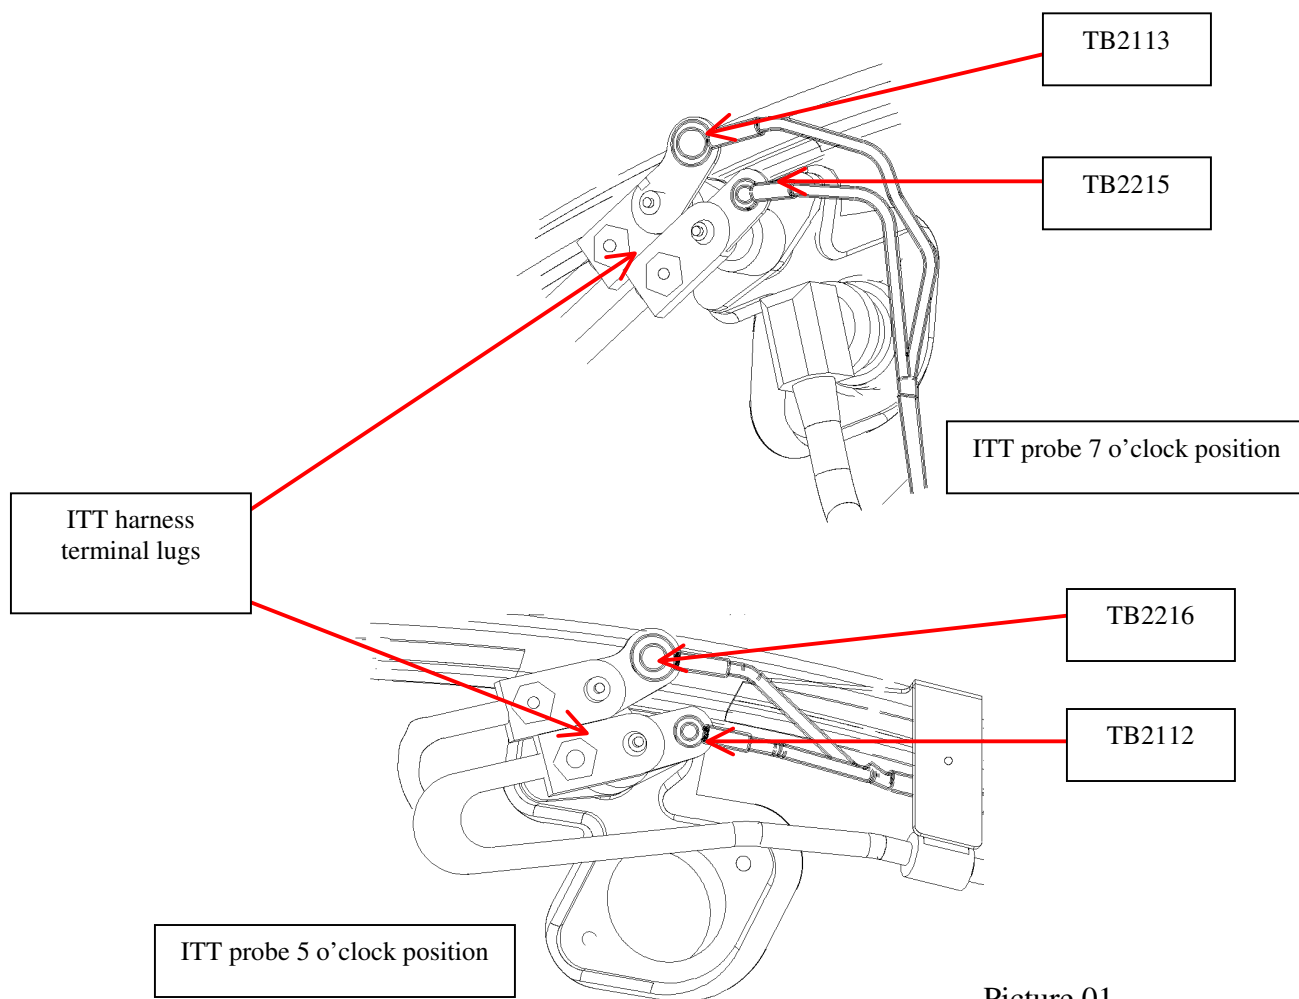
Picture 01

RRD recommends that all operators pay special attention to the position of the ITT harness terminal lugs. In case one or more of the above symptoms are observed the applicable fault isolation task in the FIM (77-21-00-810-803) should be carried out. Importantly, operators should ensure that the ITT ladder harness terminal lugs that are connected to the engine core harness (refer to picture 01) are:

- Not touching each other (minimum distance 2 mm / 0.078 inch)
- Not loose (for the torque values refer to the ITT probe installation task in the EMM)

These terminal lugs could be inadvertently disturbed while performing maintenance in the area while the core fairings are removed, e.g. during borescope inspection, igniter plug replacement. Operators who have accessed the area under the core fairings near the ITT harness connections may want to consider revisiting the area to ensure the terminal lugs have not been disturbed / are properly torque tightened, to eliminate the possibility of this fault.

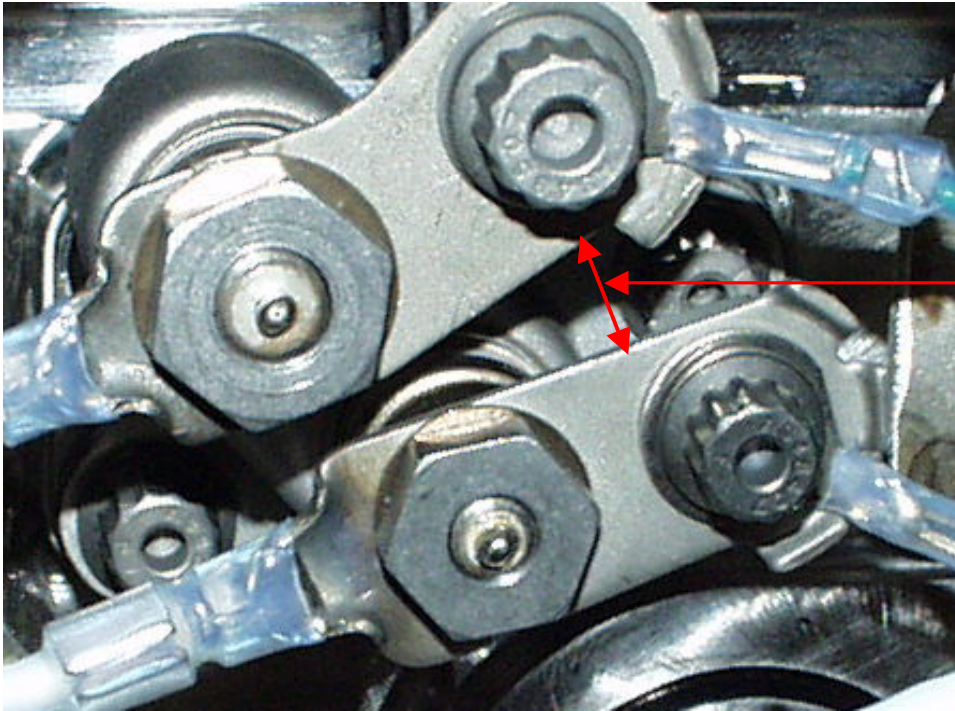
Potential contact area

Picture 02 (correctly fitted, typical for ITT probes fitted into the 5 and 7 o'clock position)
