# NOTICE TO OPERATORS BR710 ENGINES

**NTO No.: 244**

**Issue No.: 01 Date: 18-July-2018**

**TITLE: Ignition System Logic and Improved Troubleshooting Sequence for Ignition System related Starting Issues**

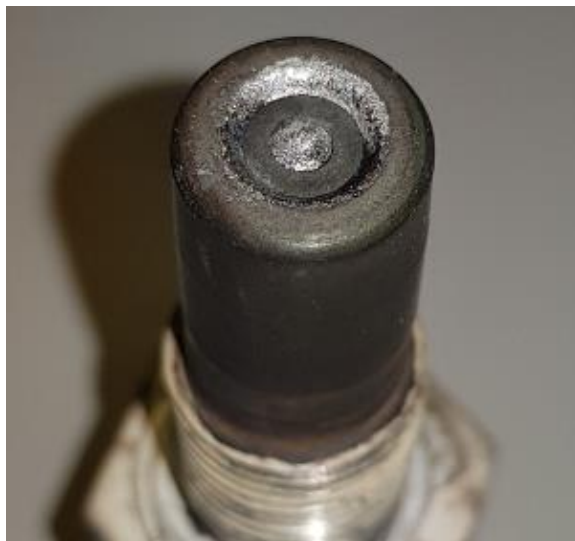
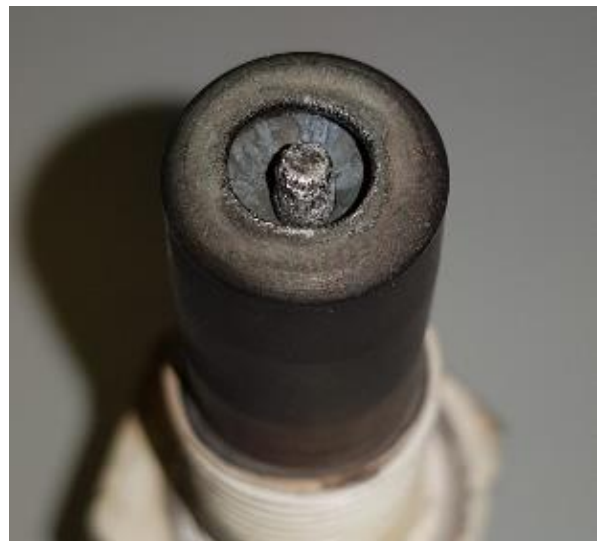
**Figure 2: Example for different wear of inboard and outboard ignitor plug**

- Based on both the reporting of several operators and the visual inspection of returned ignitor plugs, the following has been repeatedly observed. The removed inboard and outboard ignitor plugs of the same engine have worn differently, although both were installed for the same amount of flight hours and cycles. The example in Figure 2 shows that the electrode wear of the inboard ignitor plug is heavier than on the outboard one. But the wear of the semiconductor sitting between the electrodes is much more pronounced on the outboard ignitor plug. It is worth mentioning that the wear of both ignitor plugs shown below is still within the applicable wear limits. For the moment, the data quality regarding the installation position of the removed and returned ignitor plugs does not allow identifying a real pattern.

Inboard Ignitor Plug

Outboard Ignitor Plug

If practical prior to an ignitor plug removal, mark on the terminal threads of the respective ignitor plug the section which is looking forward in flow direction. The terminal threads are used to connect the ignitor plug with the ignition lead. This additional information will be used to establish a potential dependency between the installed ignitor plug orientation and the observed uneven wear of the outer electrode.
