Customer FORUM & Newsletter

WEDNESDAY, JULY 30TH, 2008

VOLUME 5 / ISSUE 15

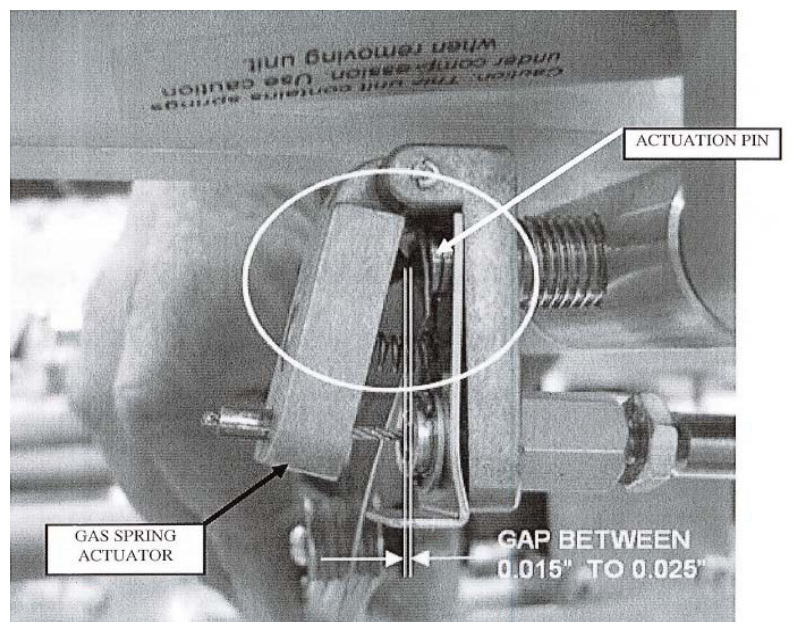
Cabin Seat Leg Rest - ATA 25

This article is intended to provide operators with additional adjustment procedures on-ground for the cabin seat leg rest (Ultraloc), which are not covered in the BE Aerospace CMM (Component Maintenance Manual).

This procedure will help reduce the possibility of leaking (creeping of the legrests) by the cylinders and prevent unnecessary replacement of units.

The cabin seat model numbers affected are: 2524.526.01-() and legrest cylinder P/N 2524.001.67-CYL.

Please refer to BE Aerospace Service Letter (Service Bulletins section) number 2524.526-25-05 revision A listed on the [CIC website](#).
