BOMBARDIER BUSINESS AIRCRAFT

Customer Forum & Newsletter

Thursday, January 28, 2021 • VOLUME 18 / ISSUE 2

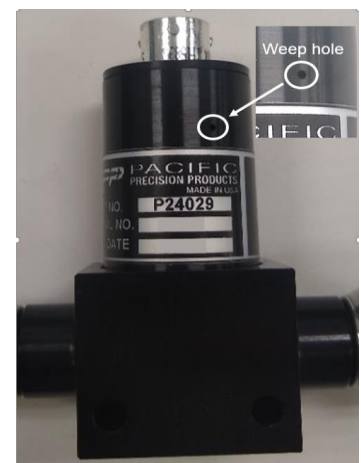
An investigation on some returned units has revealed that in some cases the unit may be declared as leaking when in fact it isn't. Once leak check fluid is applied and the unit is initially pressurized, a small bubble at the weep hole located on the cylindrical housing of the pressure switch may be present.

This is not always indicative of a leak. A diaphragm located inside the cylindrical housing will inflate upon initial pressurization and may force a small amount of air out of the cylinder. This bubble should be wiped away from the weep hole. If a new bubble forms after wiping, then a leak in the unit is present.
