Global Pax Door

Troubleshooting Familiarization
and Hints and Tips

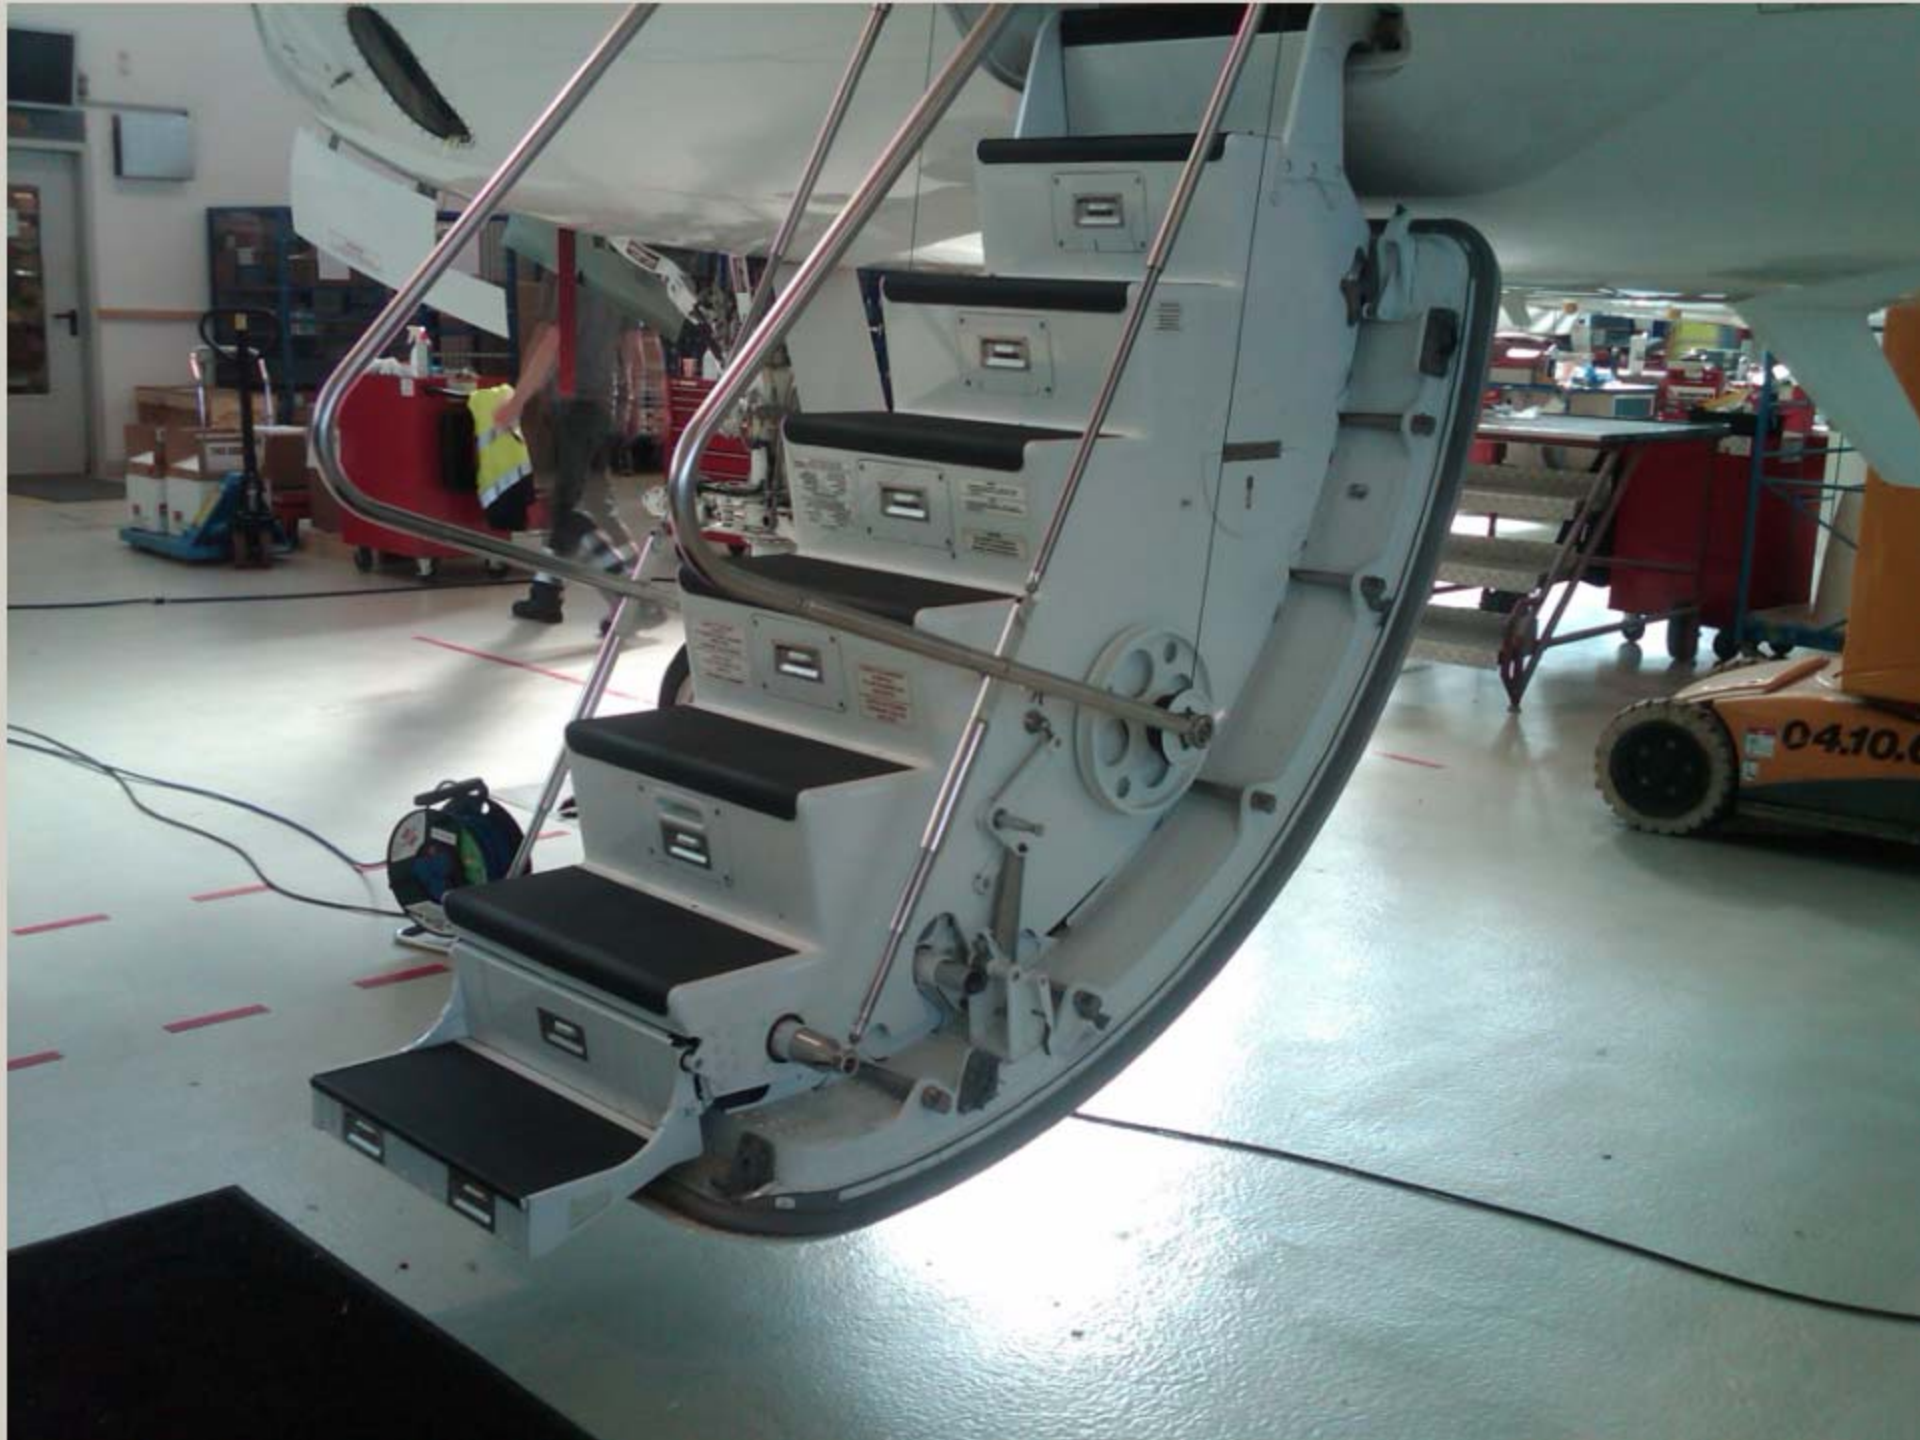
Tensator Springs

- Correct preload is 6.5 turns counterclockwise.
- When tension is put back on cables by removing rig pin---use strap to move rope pulley clockwise—never go past 6.5 turns counterclockwise to avoid springs falling off drums---lowering door onto cables moves pulley counterclockwise
- Tensator springs are life limited to 1500 landings
- Tensator springs have been found cracked and broken.
- Observe the tensator spring drums for free movement, some spindles have been found to prevent the drum from rotating freely.
- Inadequate amount of preload turns may cause the door to not pull enough to be able to easily latch the door. This may require pulling in the door from the inside or pushing from the outside before the handles can be moved to latch the door.

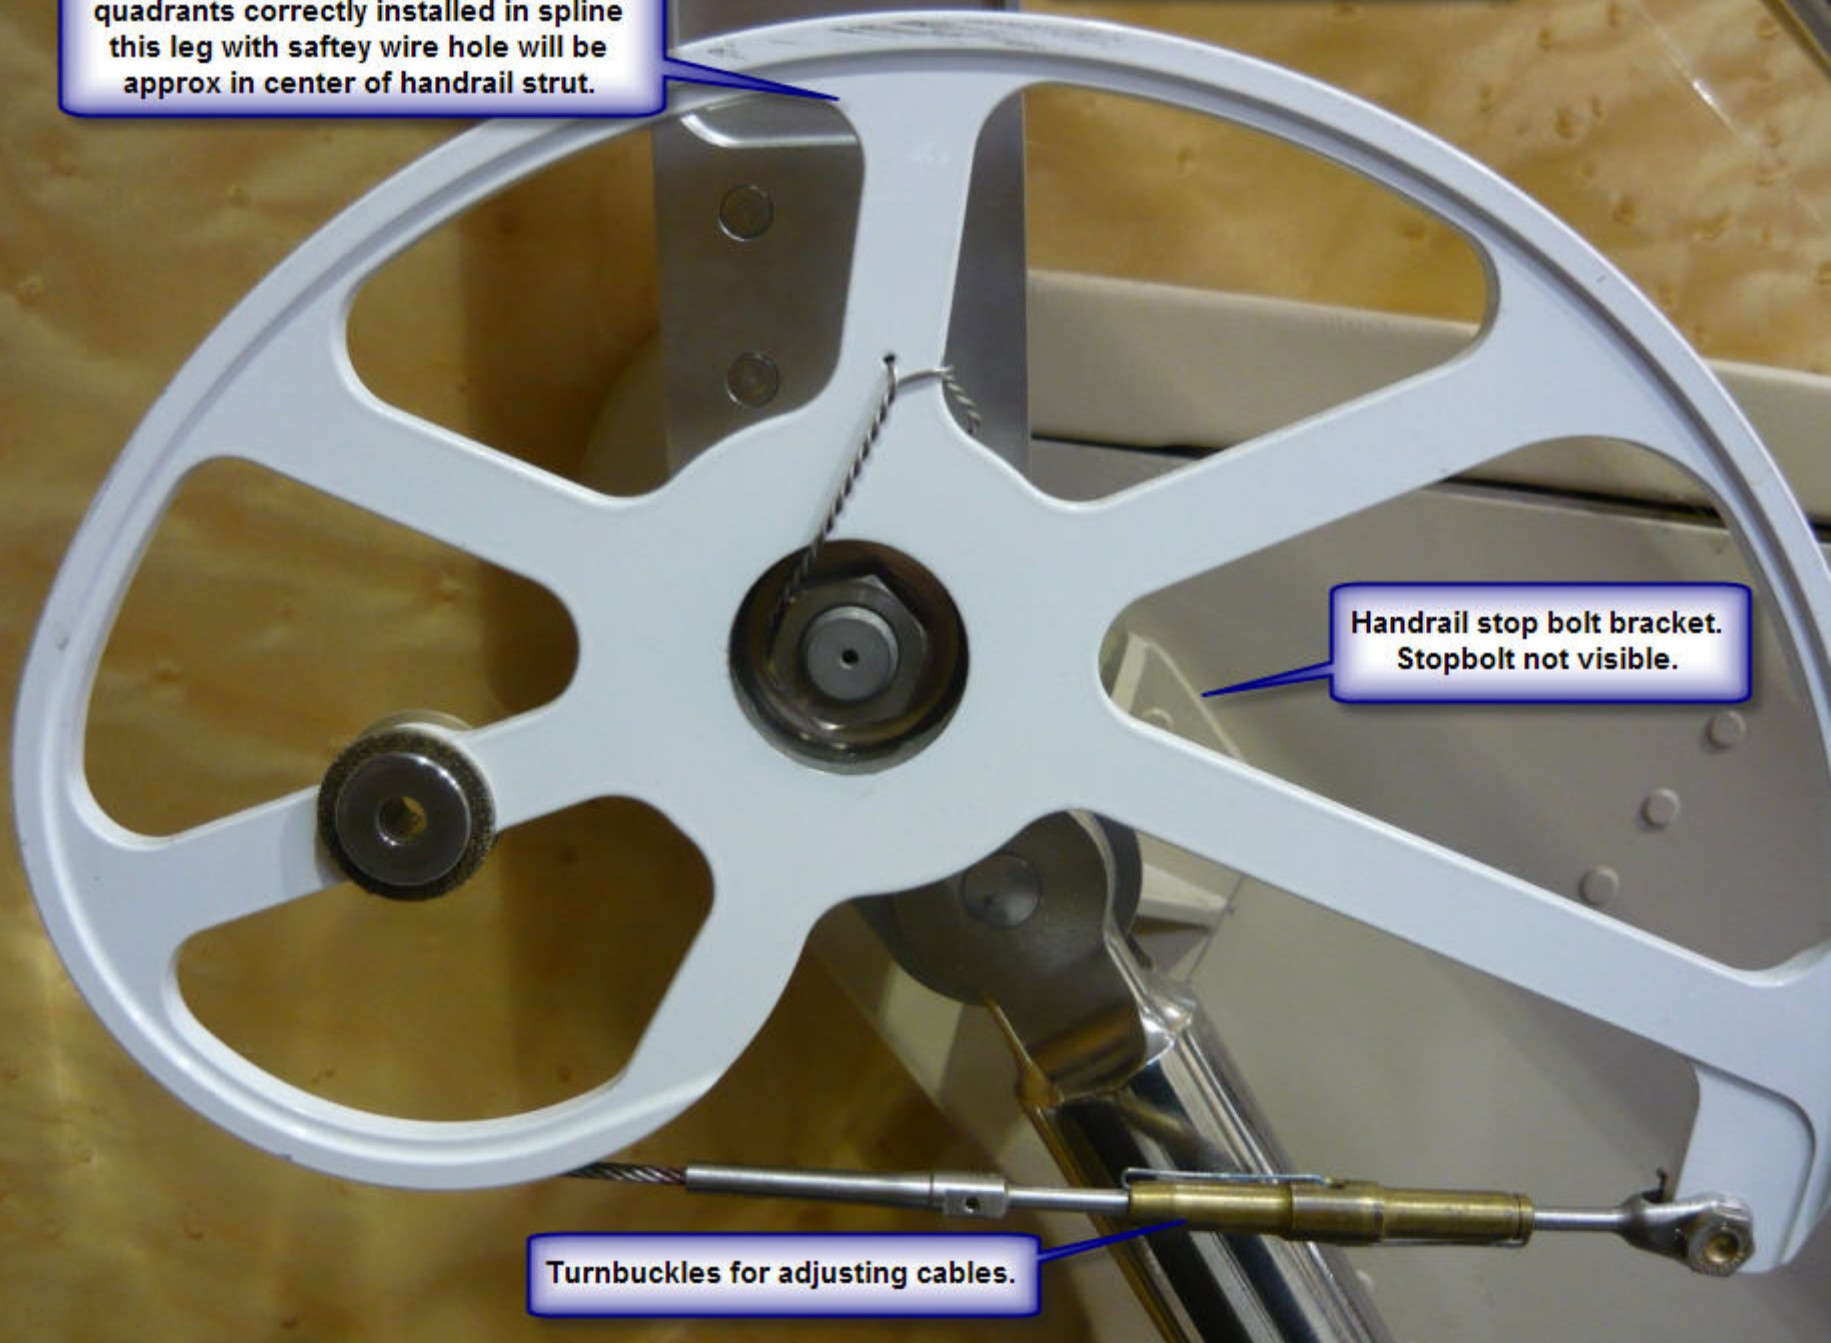
Ensure cable ends are properly engaged. Easy on installation to

With load off of handrails check for proper gap between end plate and handrail. Note no lubrication in this area. Phenolic lined bushing will get gummed up.

With door all the way open and upper quadrants correctly installed in spline this leg with safety wire hole will be approx in center of handrail strut.

Center of handrail strut.

Handrail stop bolt bracket.
Stopbolt not visible.

Turnbuckles for adjusting cables.

- Rig per AMM 52-11-00
- Different tensions for pre and post variable pulley SB 52-037. More critical than actual tension value is that tensions are equal within 10lb.

- Can use cable tensions to move door fwd or aft. Tighter tension on fwd cable will move door fwd and vice versa. Keep within 10lb.
- Upper cable quadrants on rare occasions are incorrectly manufactured. Ensure they are both equally positioned and vertical strut lines up with handrail strut.

- When pulleys and tensator springs are correctly installed and rigged the bolts and nuts on large drum are facing the fuselage with door open. If not correct---pulleys may be 180 degrees off.

- Ensure cable ball end is properly engaged in pulley.
- Variable radius pulley post SB 52-037 has more mechanical advantage at bottom end of door operation but much less when approaching airframe cutout. Unable to power through any minor deviations that were not visible pre SB.

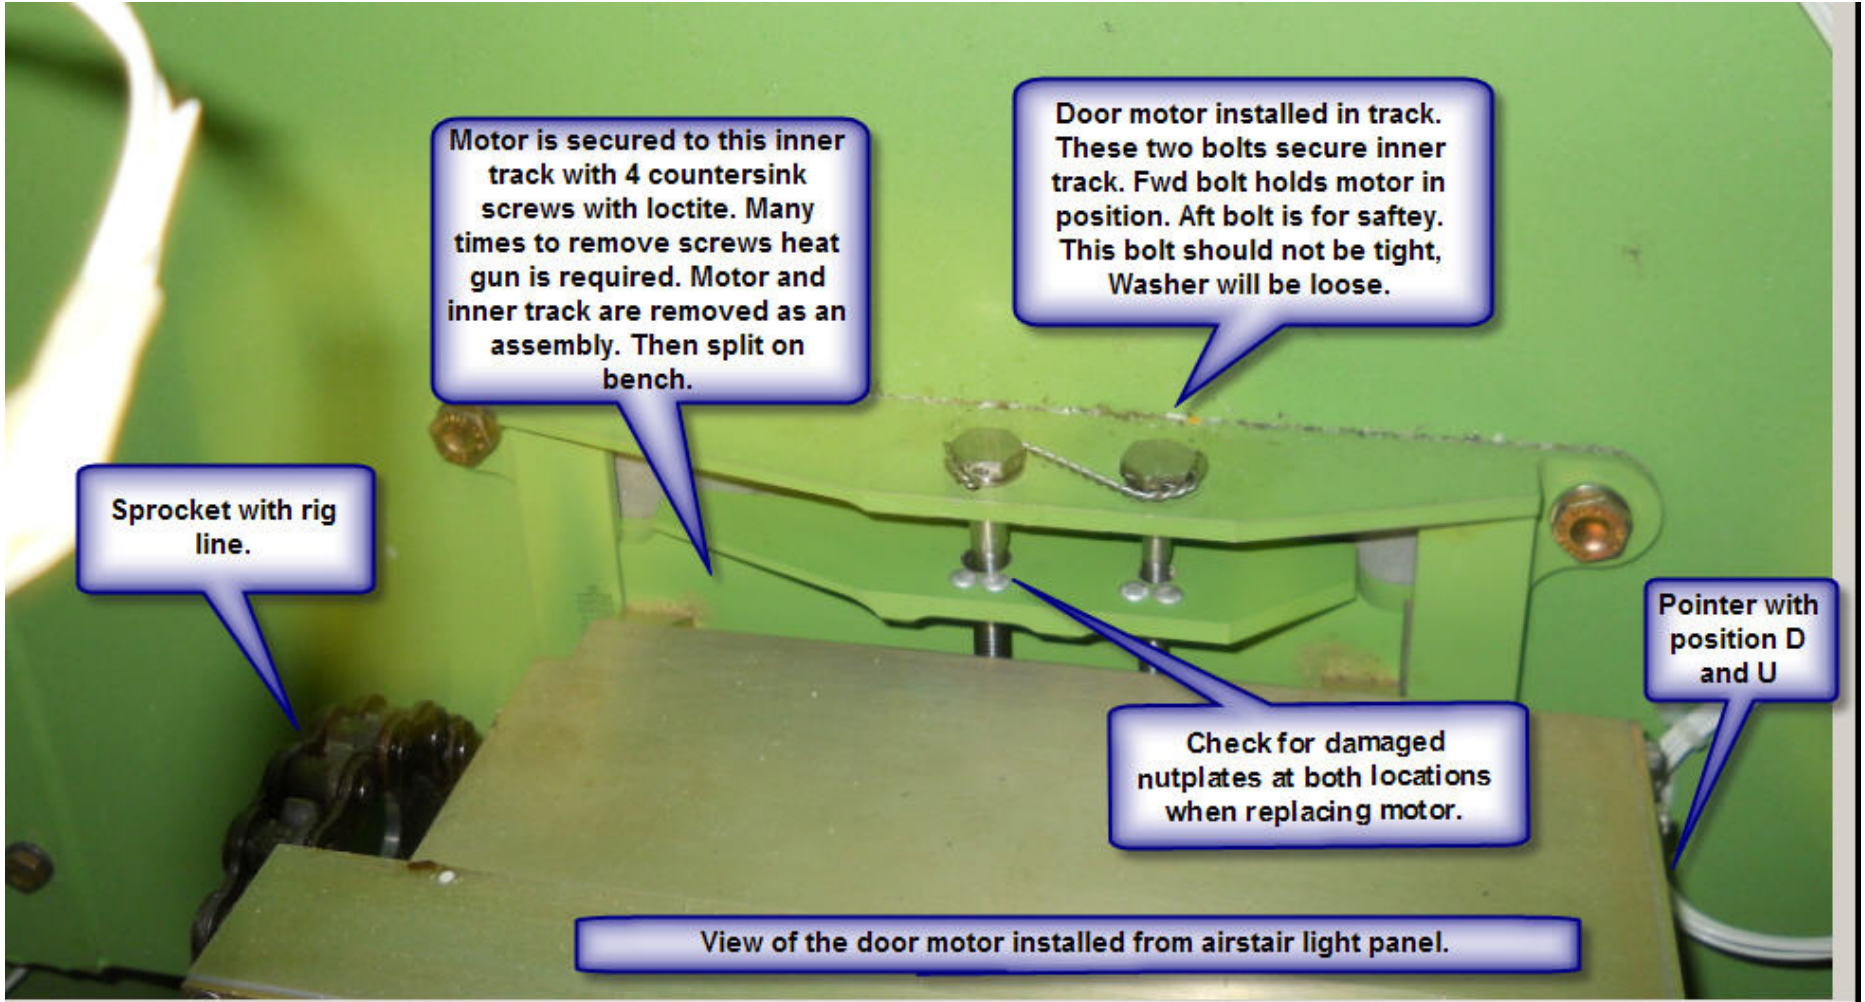
Motor is secured to this inner track with 4 countersink screws with loctite. Many times to remove screws heat gun is required. Motor and inner track are removed as an assembly. Then split on bench.

Door motor installed in track. These two bolts secure inner track. Fwd bolt holds motor in position. Aft bolt is for safety. This bolt should not be tight, Washer will be loose.

Sprocket with rig line.

Pointer with position D and U

Check for damaged nutplates at both locations when replacing motor.

View of the door motor installed from airstair light panel.

- -9 Actuator restoration--gearhead replacement due at 625L—all others not life limited.
- Rig per AMM 52-11-25---Use SB 52-037 E (c) note 1 allows 360 degree rotation to adjust speed. Turn sprocket in hard direction to move the slow down point closer to airframe when closing.

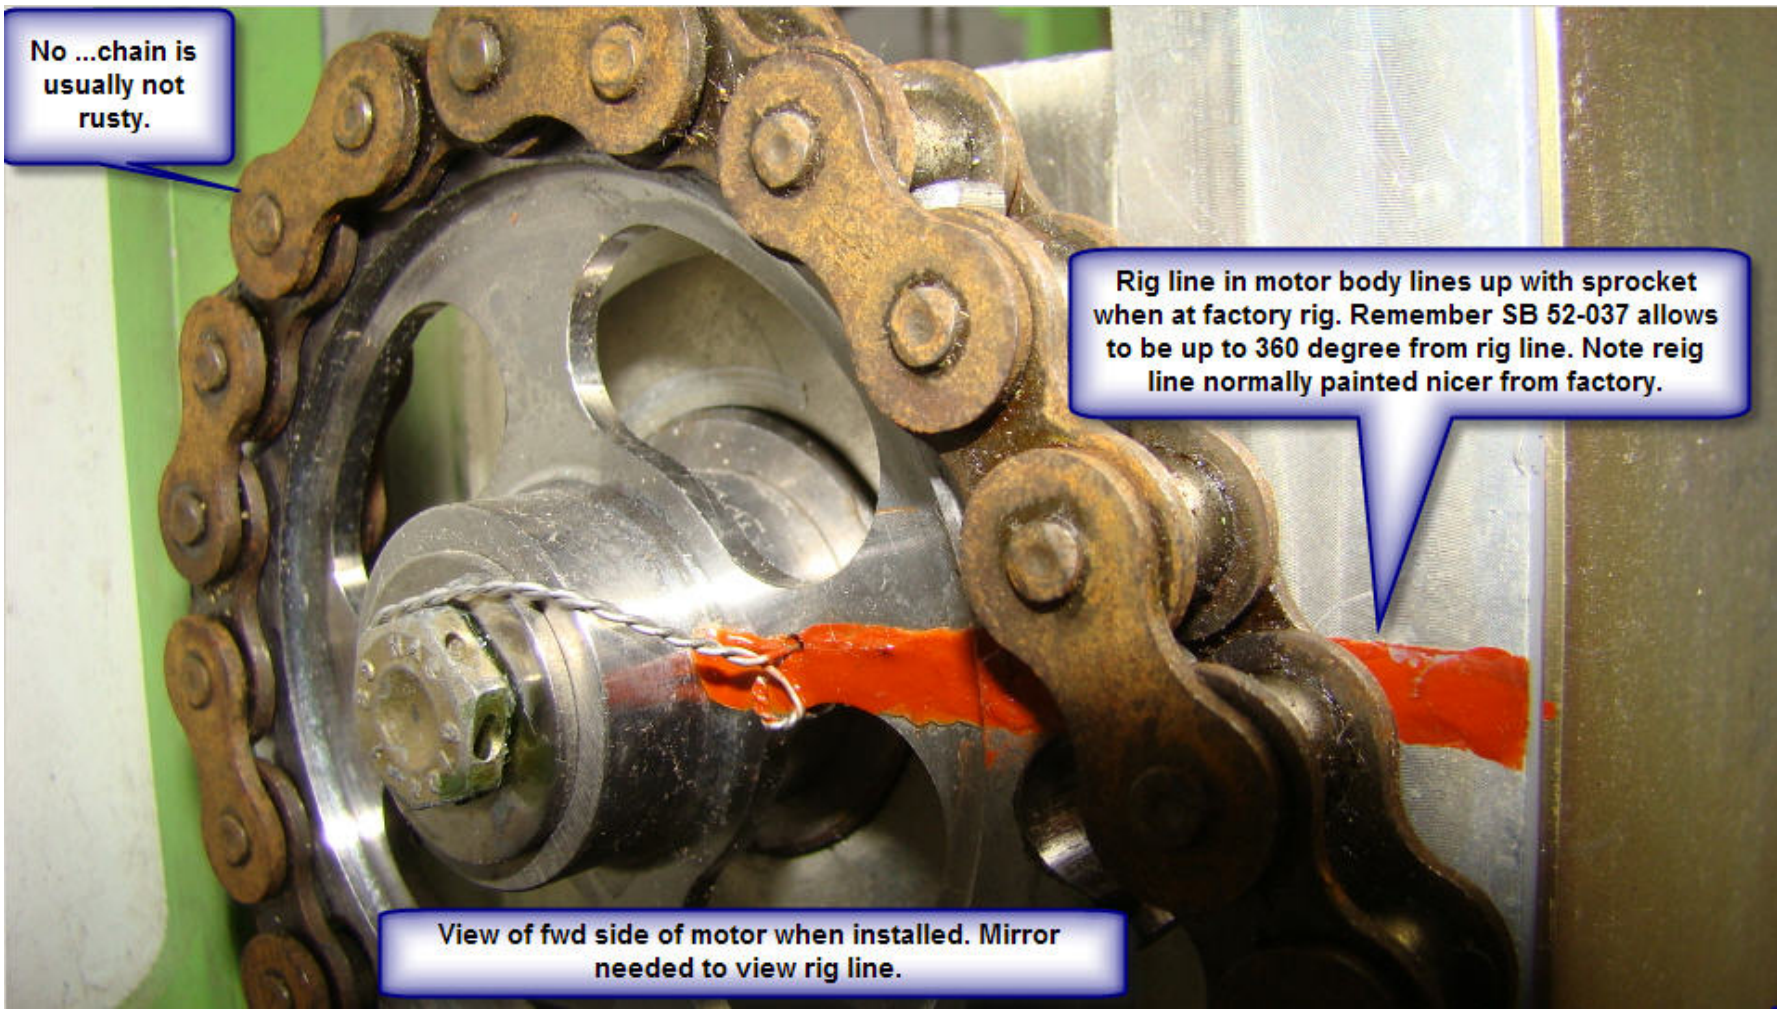
No ...chain is usually not rusty.

Rig line in motor body lines up with sprocket when at factory rig. Remember SB 52-037 allows to be up to 360 degree from rig line. Note reig line normally painted nicer from factory.

View of fwd side of motor when installed. Mirror needed to view rig line.

Motor will come rigged from vendor
pointer will line up at the D. If you
turn the sprocket 360 degree in
hard direction it will be past the D a
hair.

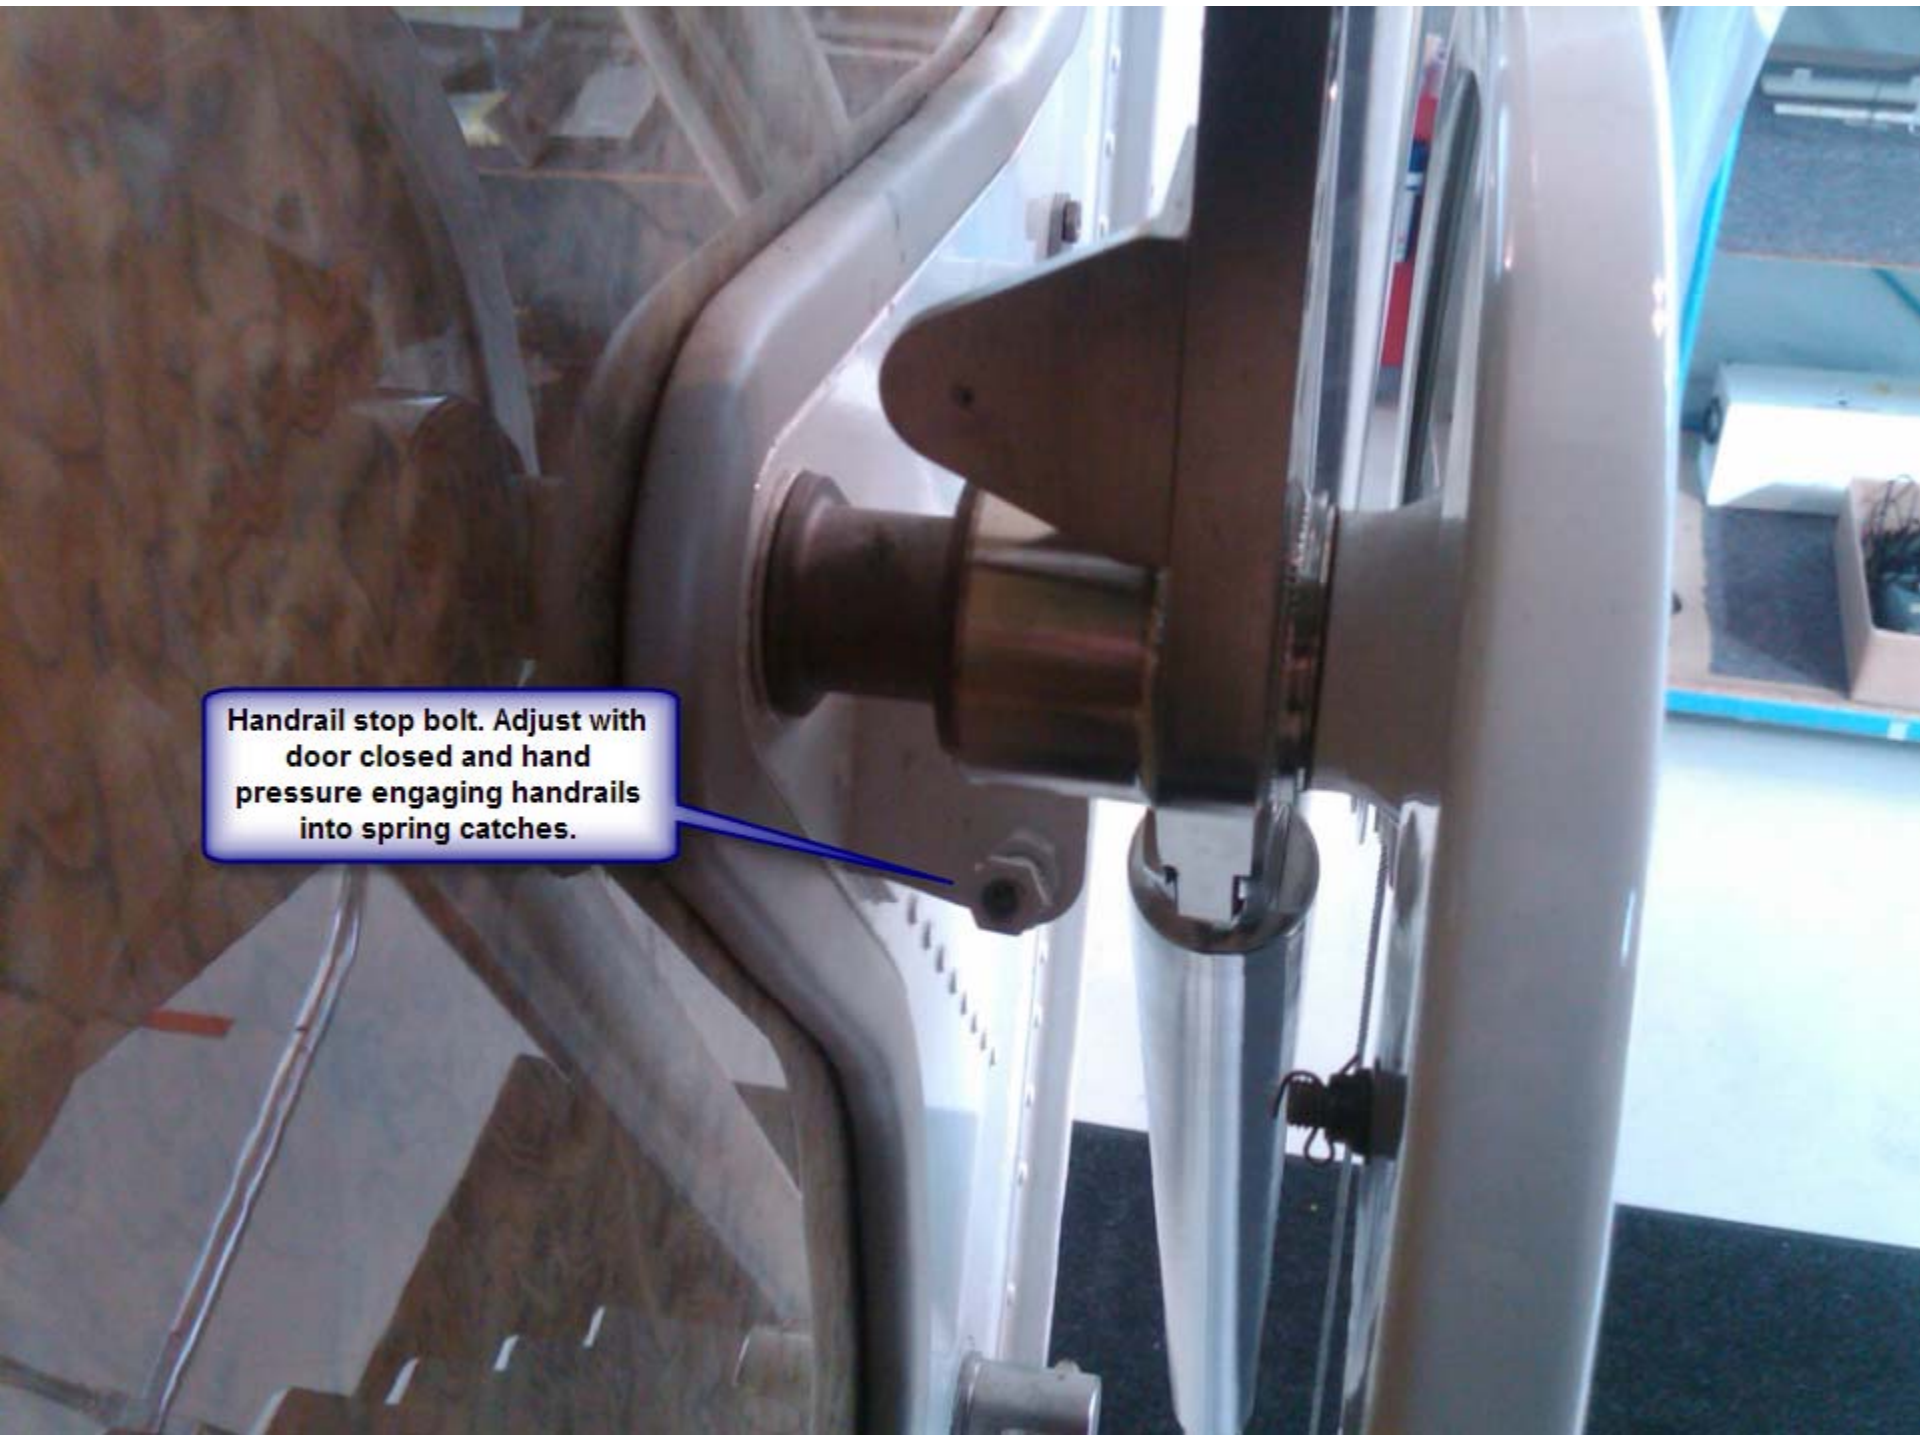
A close-up photograph of a handrail stop bolt on a white metal structure. The bolt is a cylindrical metal component with a hexagonal base. A blue callout box with a white border and a blue pointer line points to the bolt. The background shows a white metal frame and a wooden floor.

Handrail stop bolt. Adjust with door closed and hand pressure engaging handrails into spring catches.

GSE available for swaging pins to replace sections of handrail struts. G700-52113-1

- Some earlier handrails were installed under an STC and need to be maintained per IFCA.
- Rig handrails per AMM 52-11-21.
- Pay particular attention to handrail stop bolts in stowed position. Too tight and door will not close. Hold handrails into spring latches then measure .005 to .010 at stop bolt per steps 18-19.
- Do not operate door with protection on handrails –can jam and break.
- Handrail extensions are installed at completion.. See DTS.
- Lubricate handrails Ref SMM use Royco 363 on telescope tubes. This will alleviate handrail chatter. Best to lubricate with door closed so that lubricant seeps into tubes. Only lubricate telescoping tubes do not lube phenolic bushing locations.
- Handrail lower telescope tubes can break. We have procedure and tooling to replace sections. Check pricing first.. May be cheaper to replace entire assy.

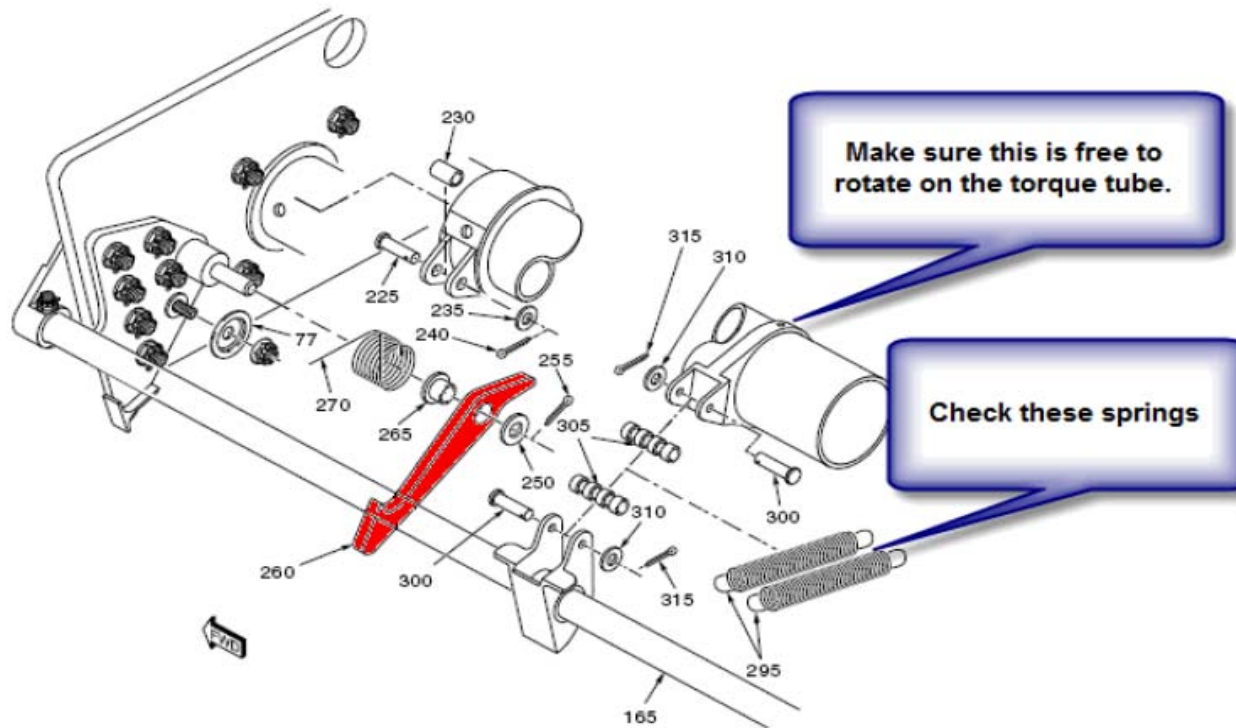
If lower step is binding....

View looking fwd
under lower step.

Inspect spring for any signs of the coils
with deformation. This would indicate
spring hanging up when step is opening at
the center point of lever when the spring
is fully compressed and kinks.

Inspect this lever for
freedom of movement
around tube. It should
be loose and free of
debris.

- No lower step motor from 9001- 9133. Introduced via SB
- Rig door actuator speed to slow door down when door is vertical during closing to aid in step folding. See actuator page. For pre 9133 (no step motor).
- With door open if lower step has excessive bounce rig stop brackets ref AMM 52-11-00 rig step (d).
- If lower step fails to fold and a loud bang is heard then it folds---(with or without step motor)--check the springs on the steps. They have been known to bind due to FOD on collar or springs that are damaged or too long.
- If lower step fails to fold (with step motor) starts folding then slowly extends down---possible bad step motor or chain has stretched. New style step motor available -3 replaces motor and chain.

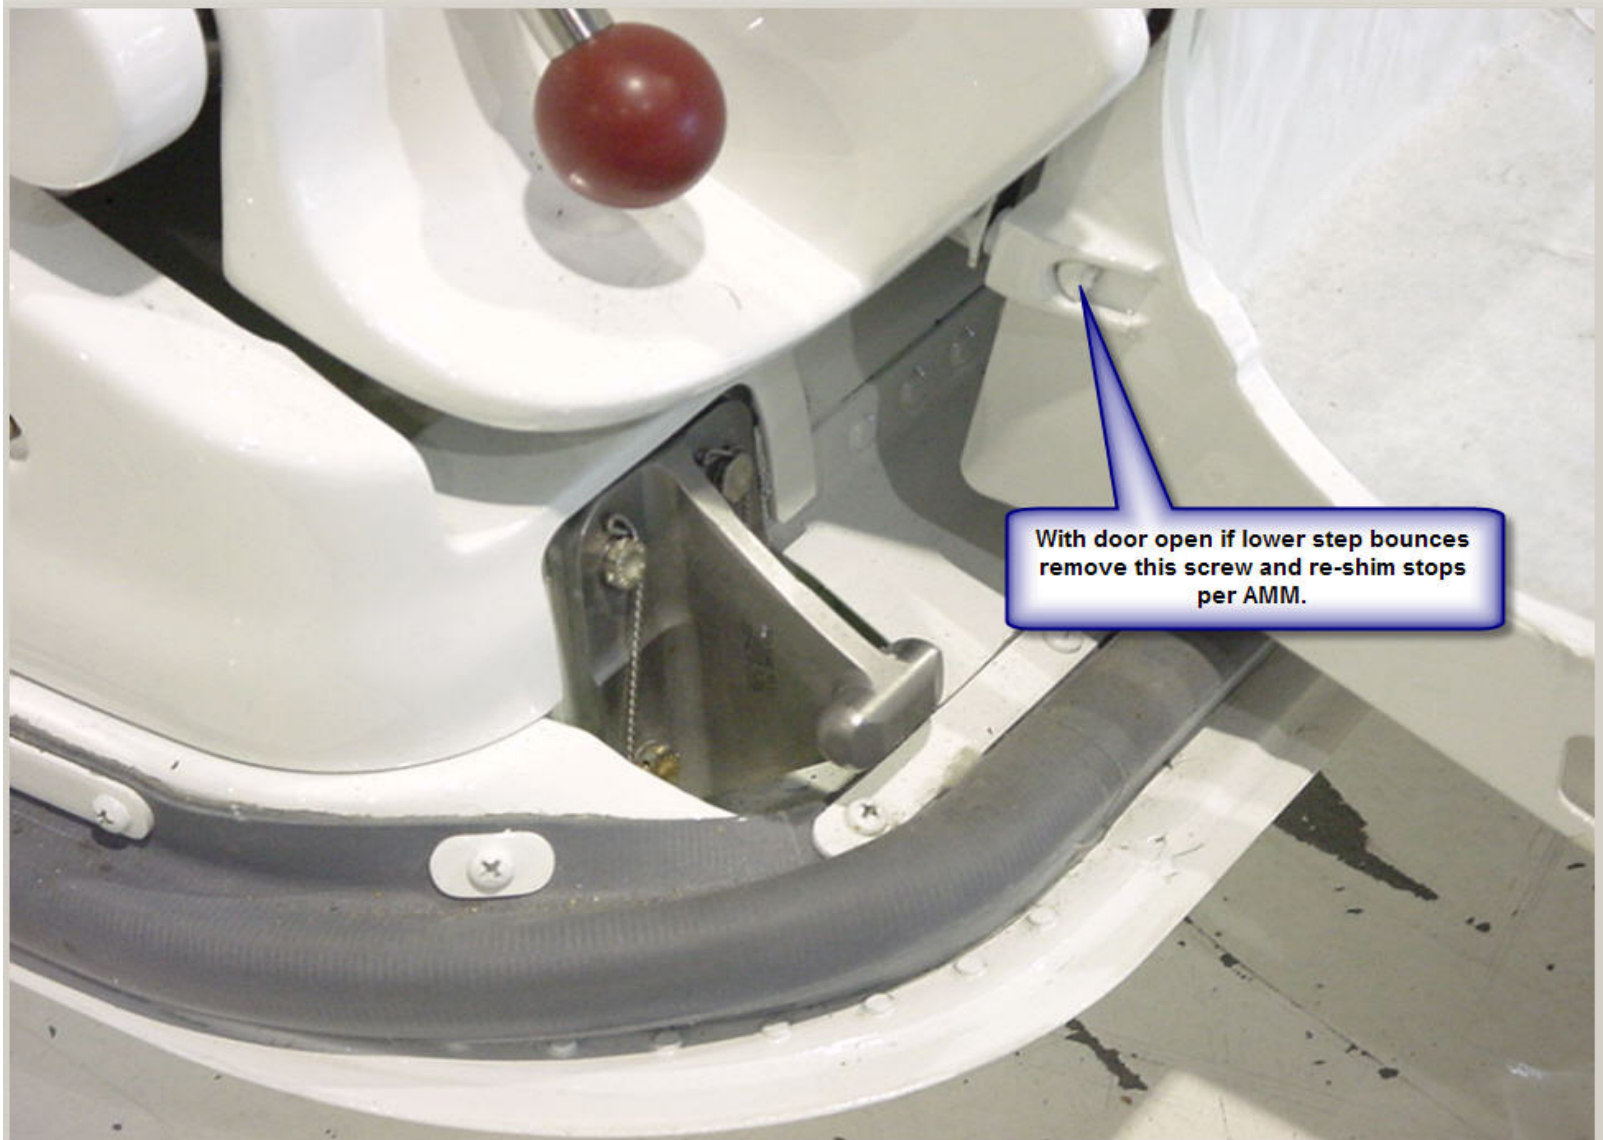
**With door open if lower step bounces
remove this screw and re-shim stops
per AMM.**

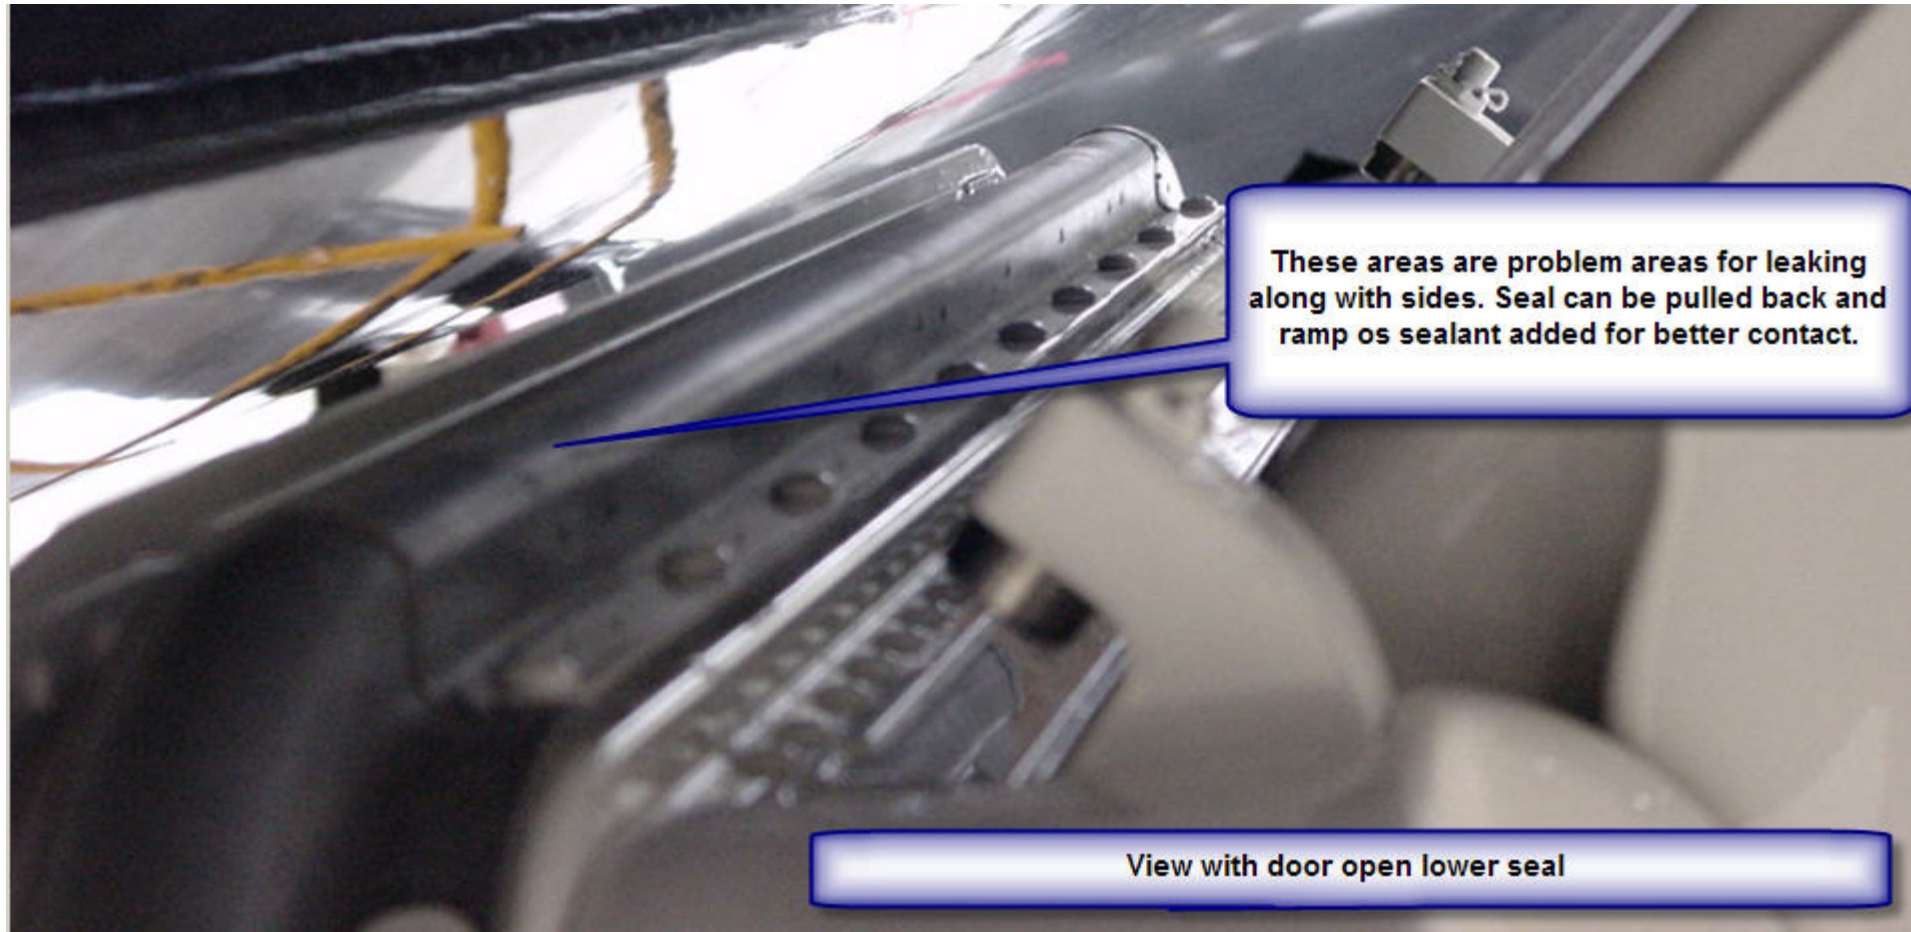
These areas are problem areas for leaking along with sides. Seal can be pulled back and ramp or sealant added for better contact.

View with door open lower seal

- Seal is reparable per SRM 52-00-14 with RTV 157—for small nicks see general section in repair.
- If the seal is leaking due to poor contact on seal striker—can be repaired by applying PRC under seal (gap sealing) to push seal assy over the seal striker. Ref AMM 52-11-37 R&R of seal step 3 (g).

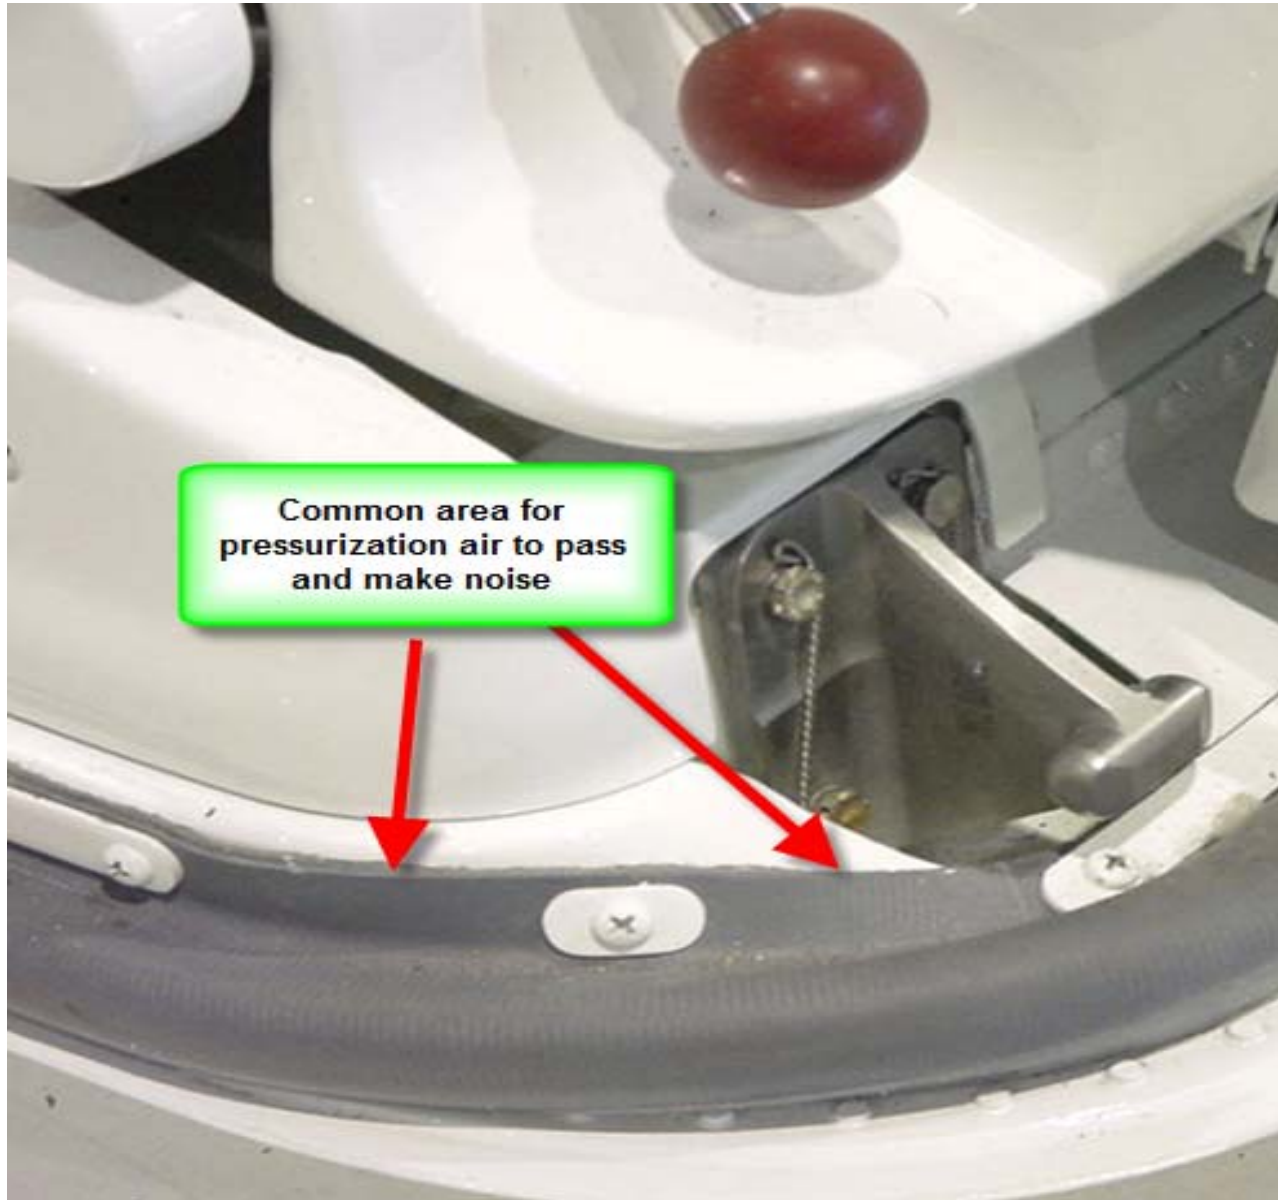
**Common area for
pressurization air to pass
and make noise**

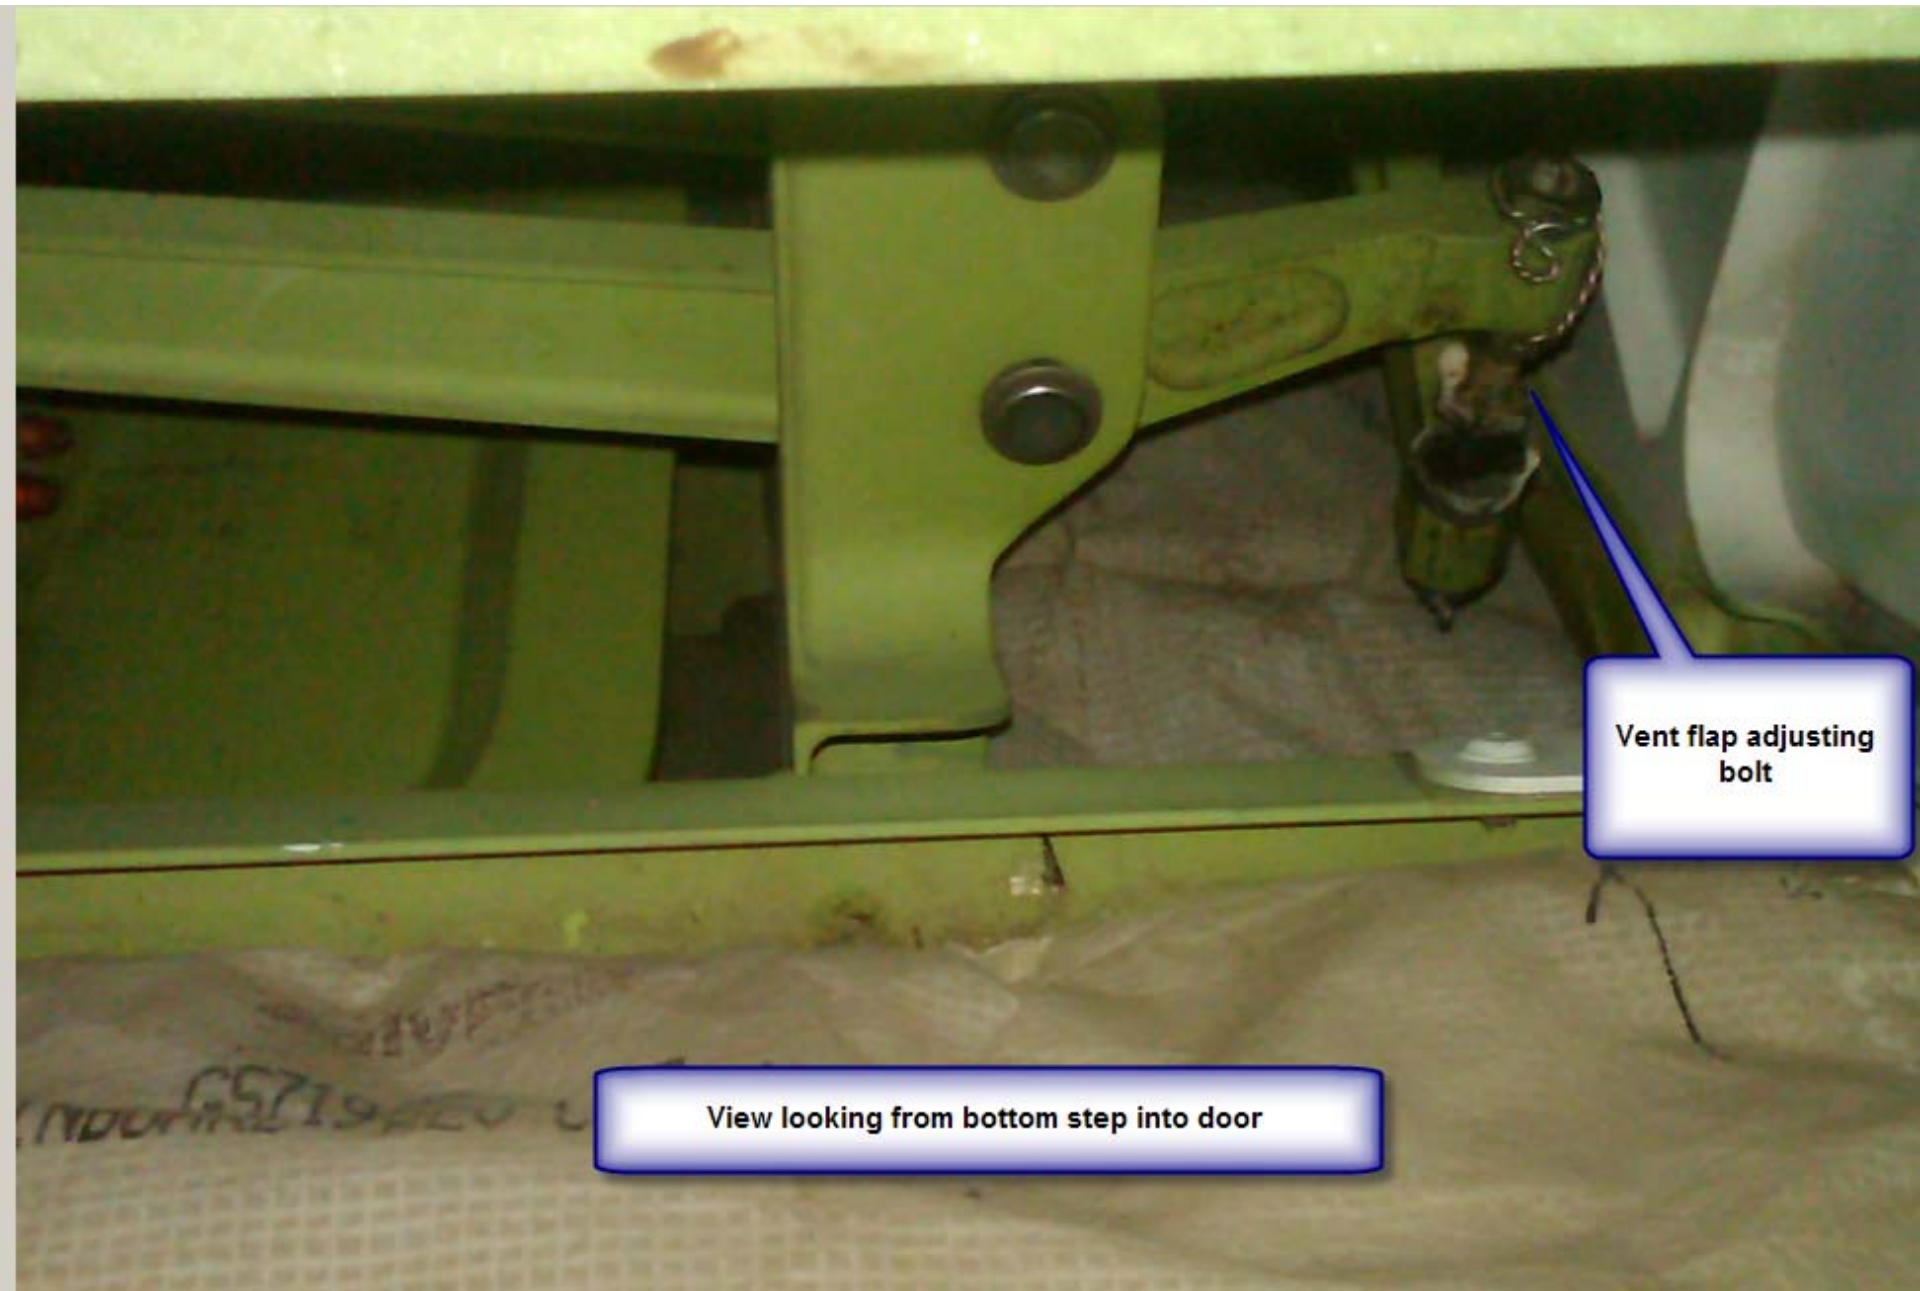
Vent flap adjusting bolt

View looking from bottom step into door

These stops added per SB.

Particular attention to be paid to shims and washer stack up. There is a spacer on th inside. Also have seen bearing loose.

- Adjust per AMM 52-11-69. Pay close attention not to apply too much pressure to door—this condition will increase the unlatching force required to open door especially from inside. The adjusting bolt should be adjusted until vent flap seal contacts no more.
- Check for migrating bearing—repairable per SB 52-029
- Check for broken springs and incorrectly installed hinge hardware.

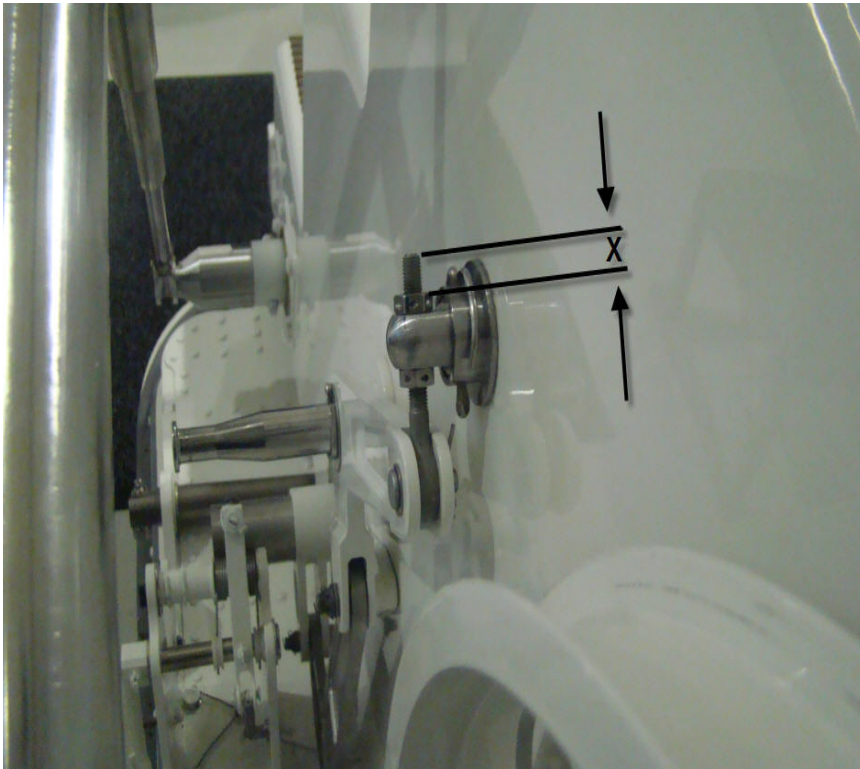
- **To tilt top of door aft;**
Decreasing X on forward side tilts door aft.
Increasing X on aft side tilts door aft.
- **To tilt top of door forward;**
Increasing X on forward side tilts door forward
Decreasing X on aft side tilts door forward
- **To lift door**
Decrease X on both sides
- **To lower door**
Increase X on both sides.
