Global Pax Door

Troubleshooting Familiarization
and Hints and Tips

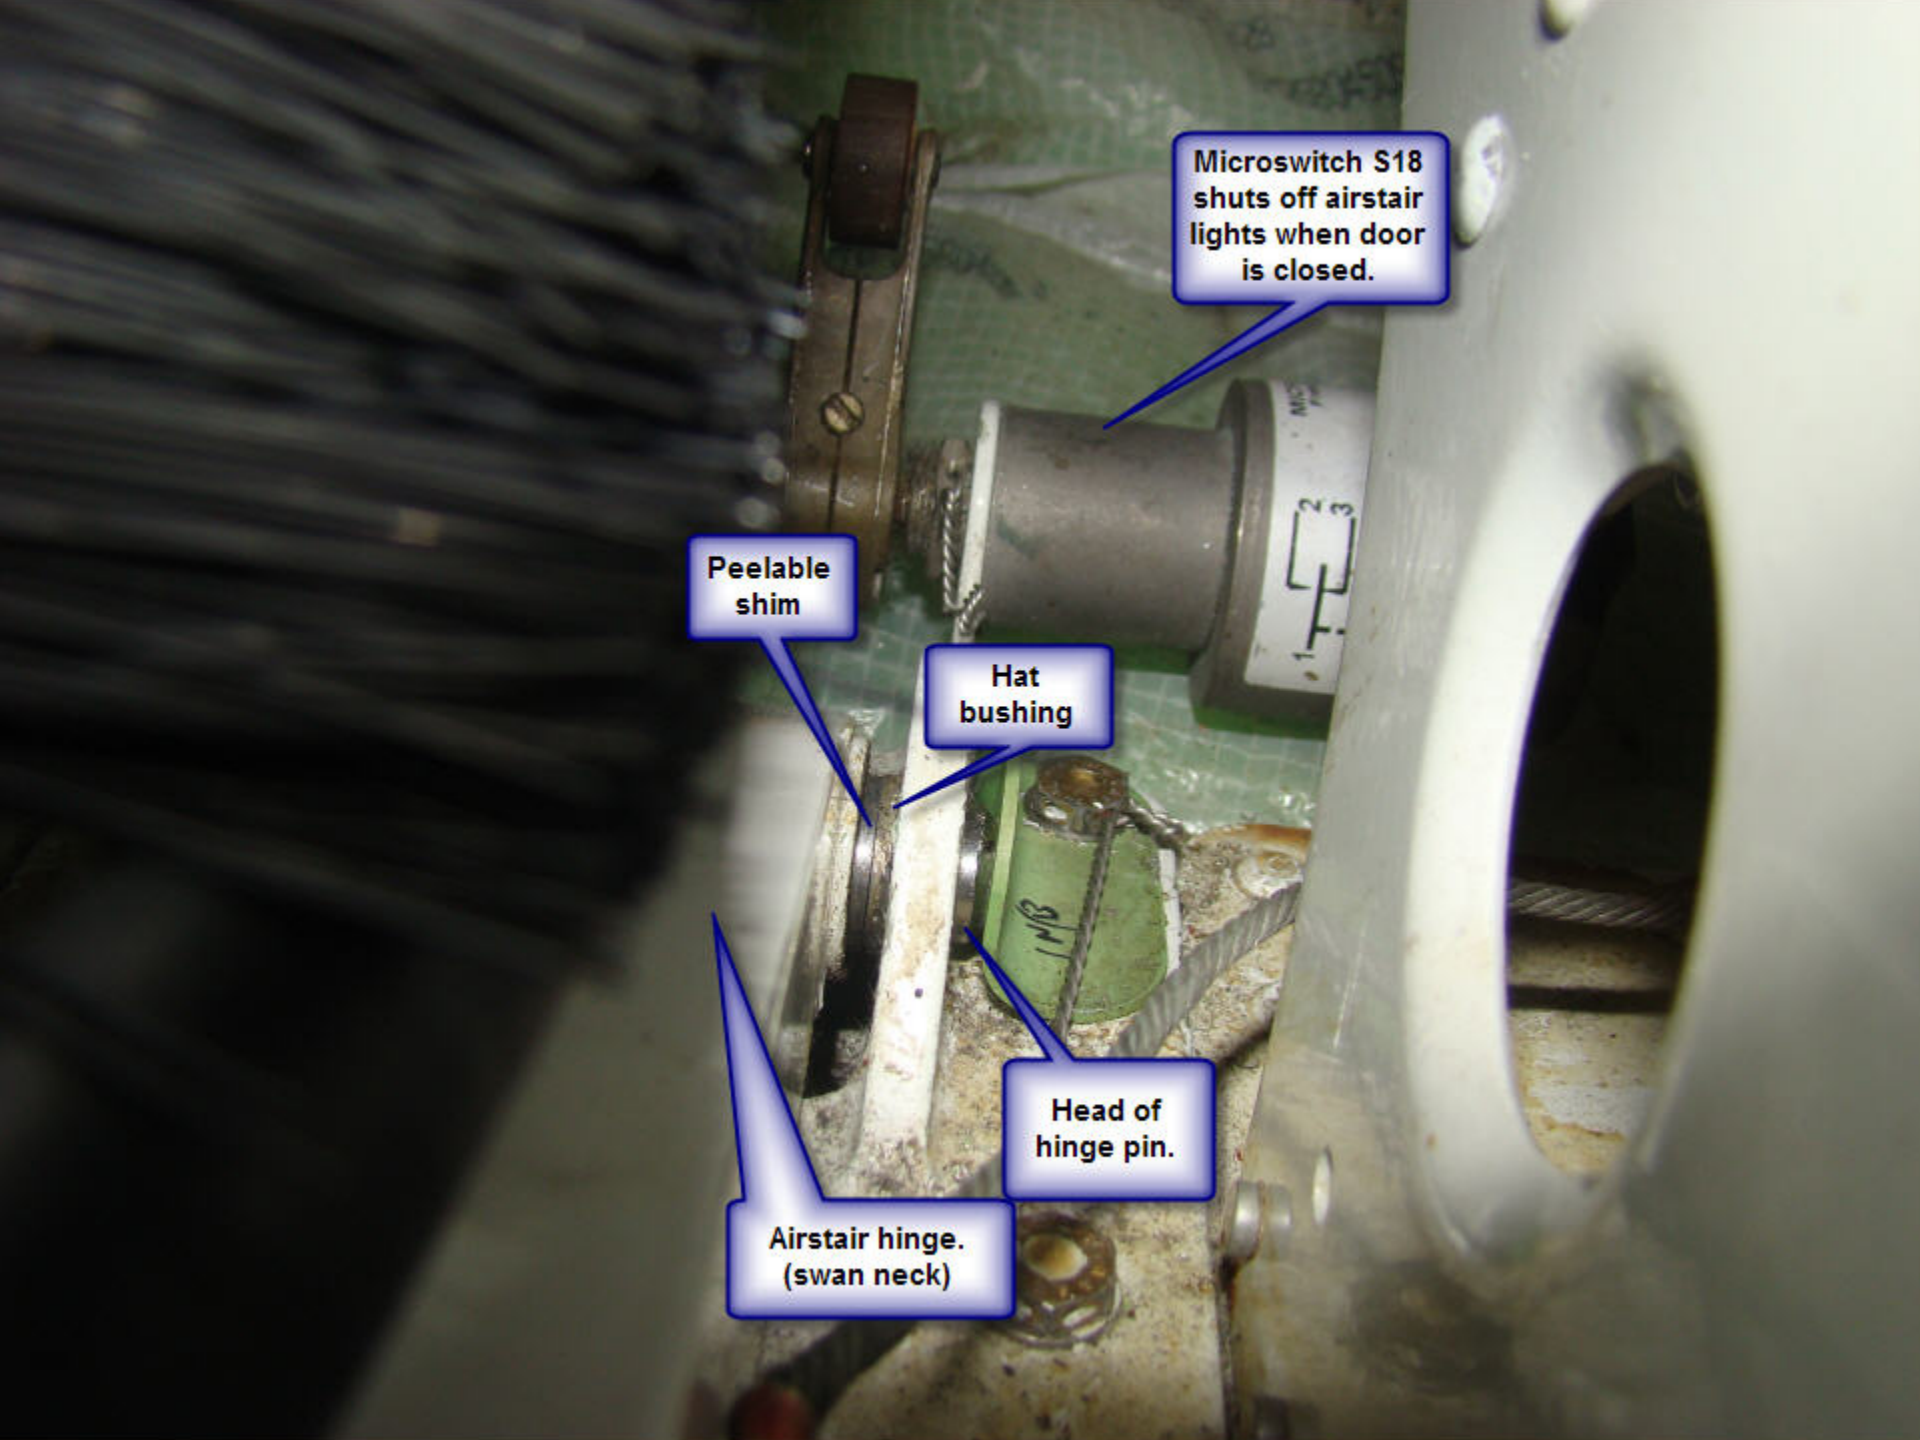
Airframe guide roller

Knock off lever fitting

Typical seal striker damage from abutment pins. Repairable per REO

Microswitch S18
shuts off airstair
lights when door
is closed.

Peelable
shim

Hat
bushing

Head of
hinge pin.

Airstair hinge.
(swan neck)

- Shimming the fwd (swan neck) airstair hinge is covered in rig AMM 52-11-00 step (a). Only the fwd hinge is shimmed and typically shim is only on one side of swan neck. This will move the door evenly fwd or aft.

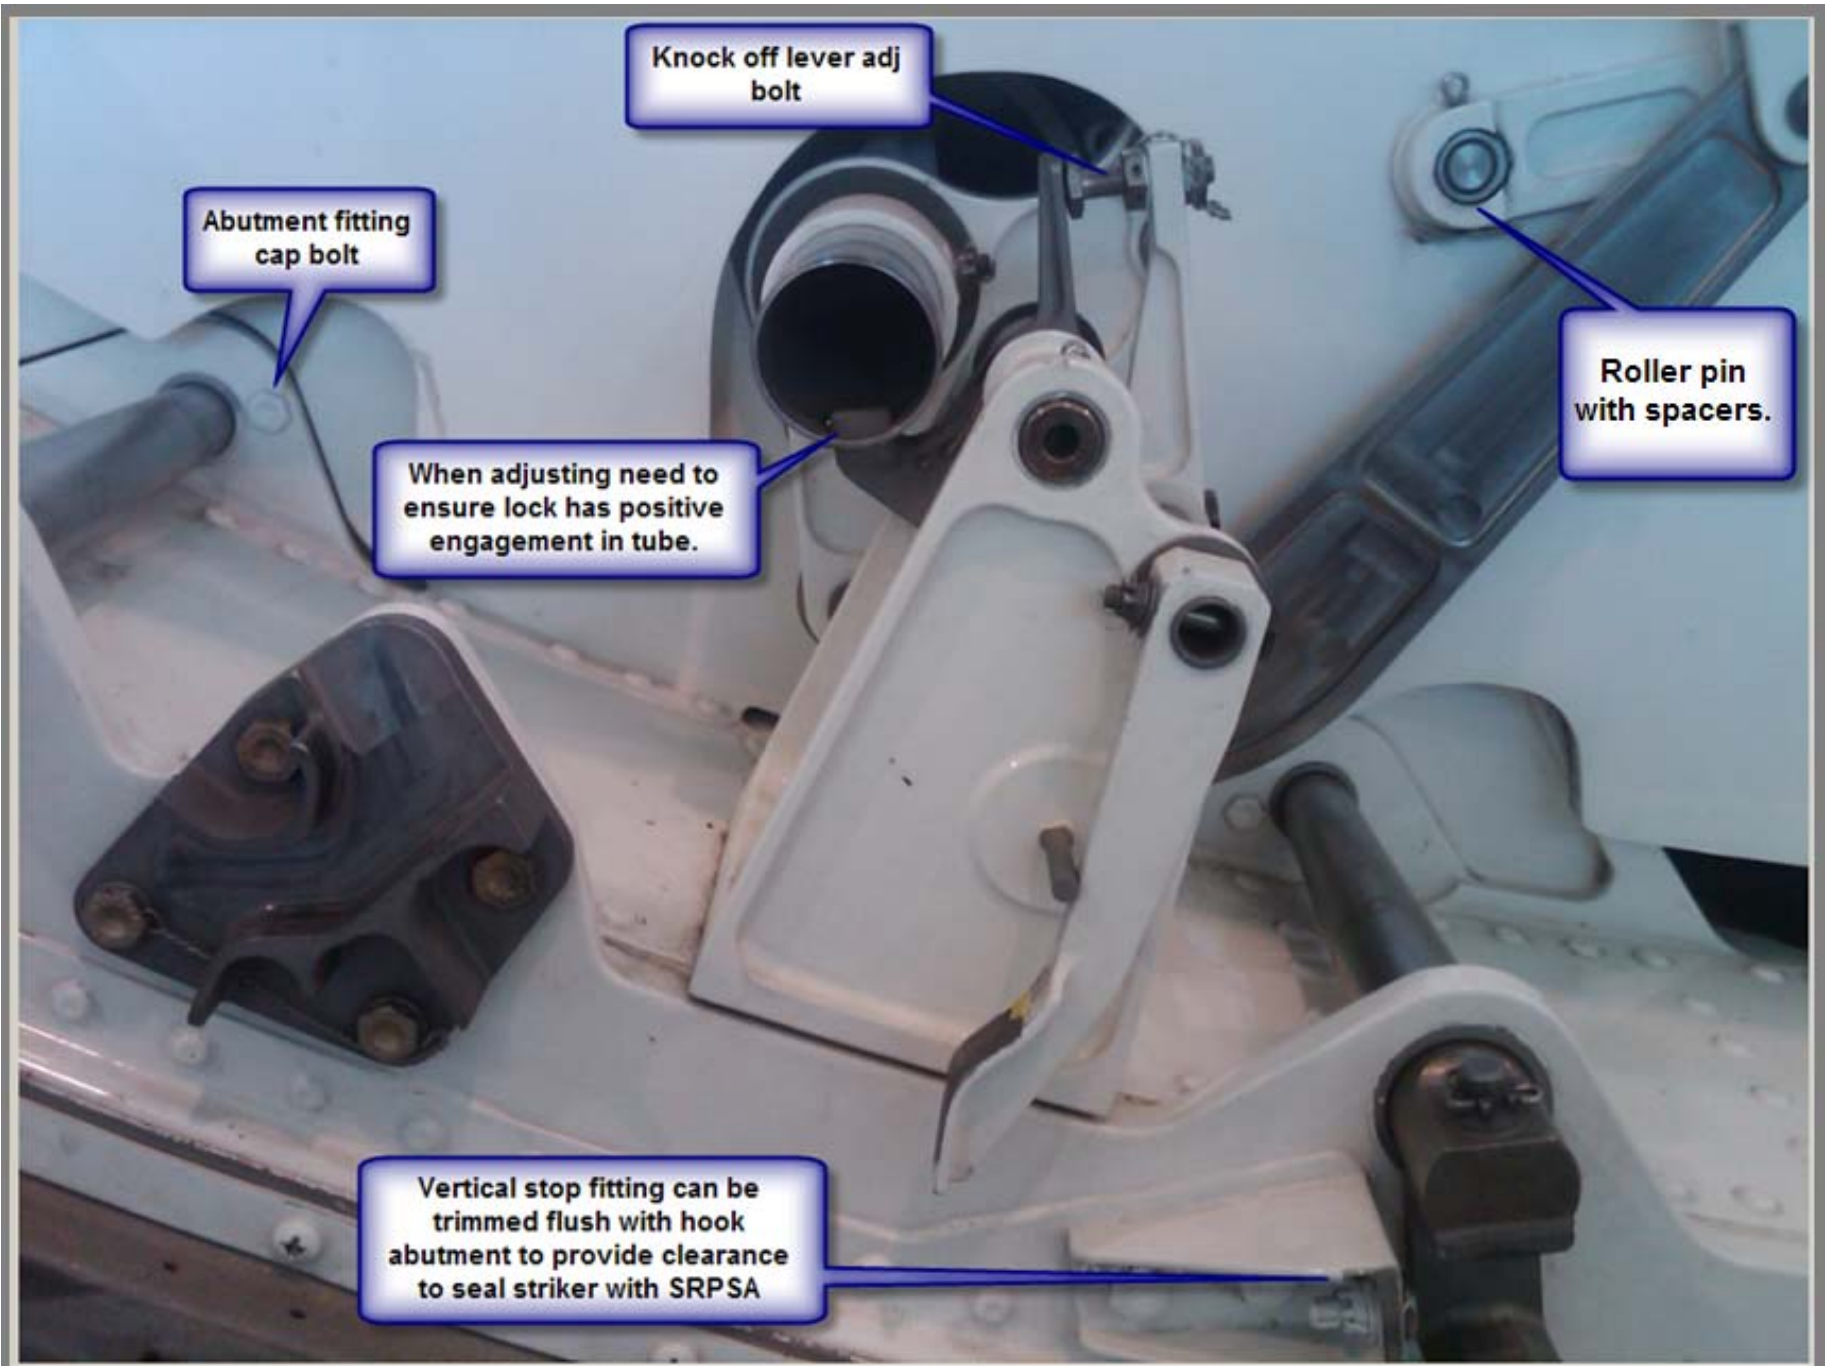
Washer is added under abutment fitting end cap to move abutment fitting closer to door and away from seal striker. SRPSA needed.

View inside of door

Knock off lever adj bolt

Abutment fitting cap bolt

When adjusting need to ensure lock has positive engagement in tube.

Roller pin with spacers.

Vertical stop fitting can be trimmed flush with hook abutment to provide clearance to seal striker with SRPSA

- In some cases necessary to shim the abutment pin retainers on door to move abutment pins into door to provide clearance to seal striker. Via srpsa.

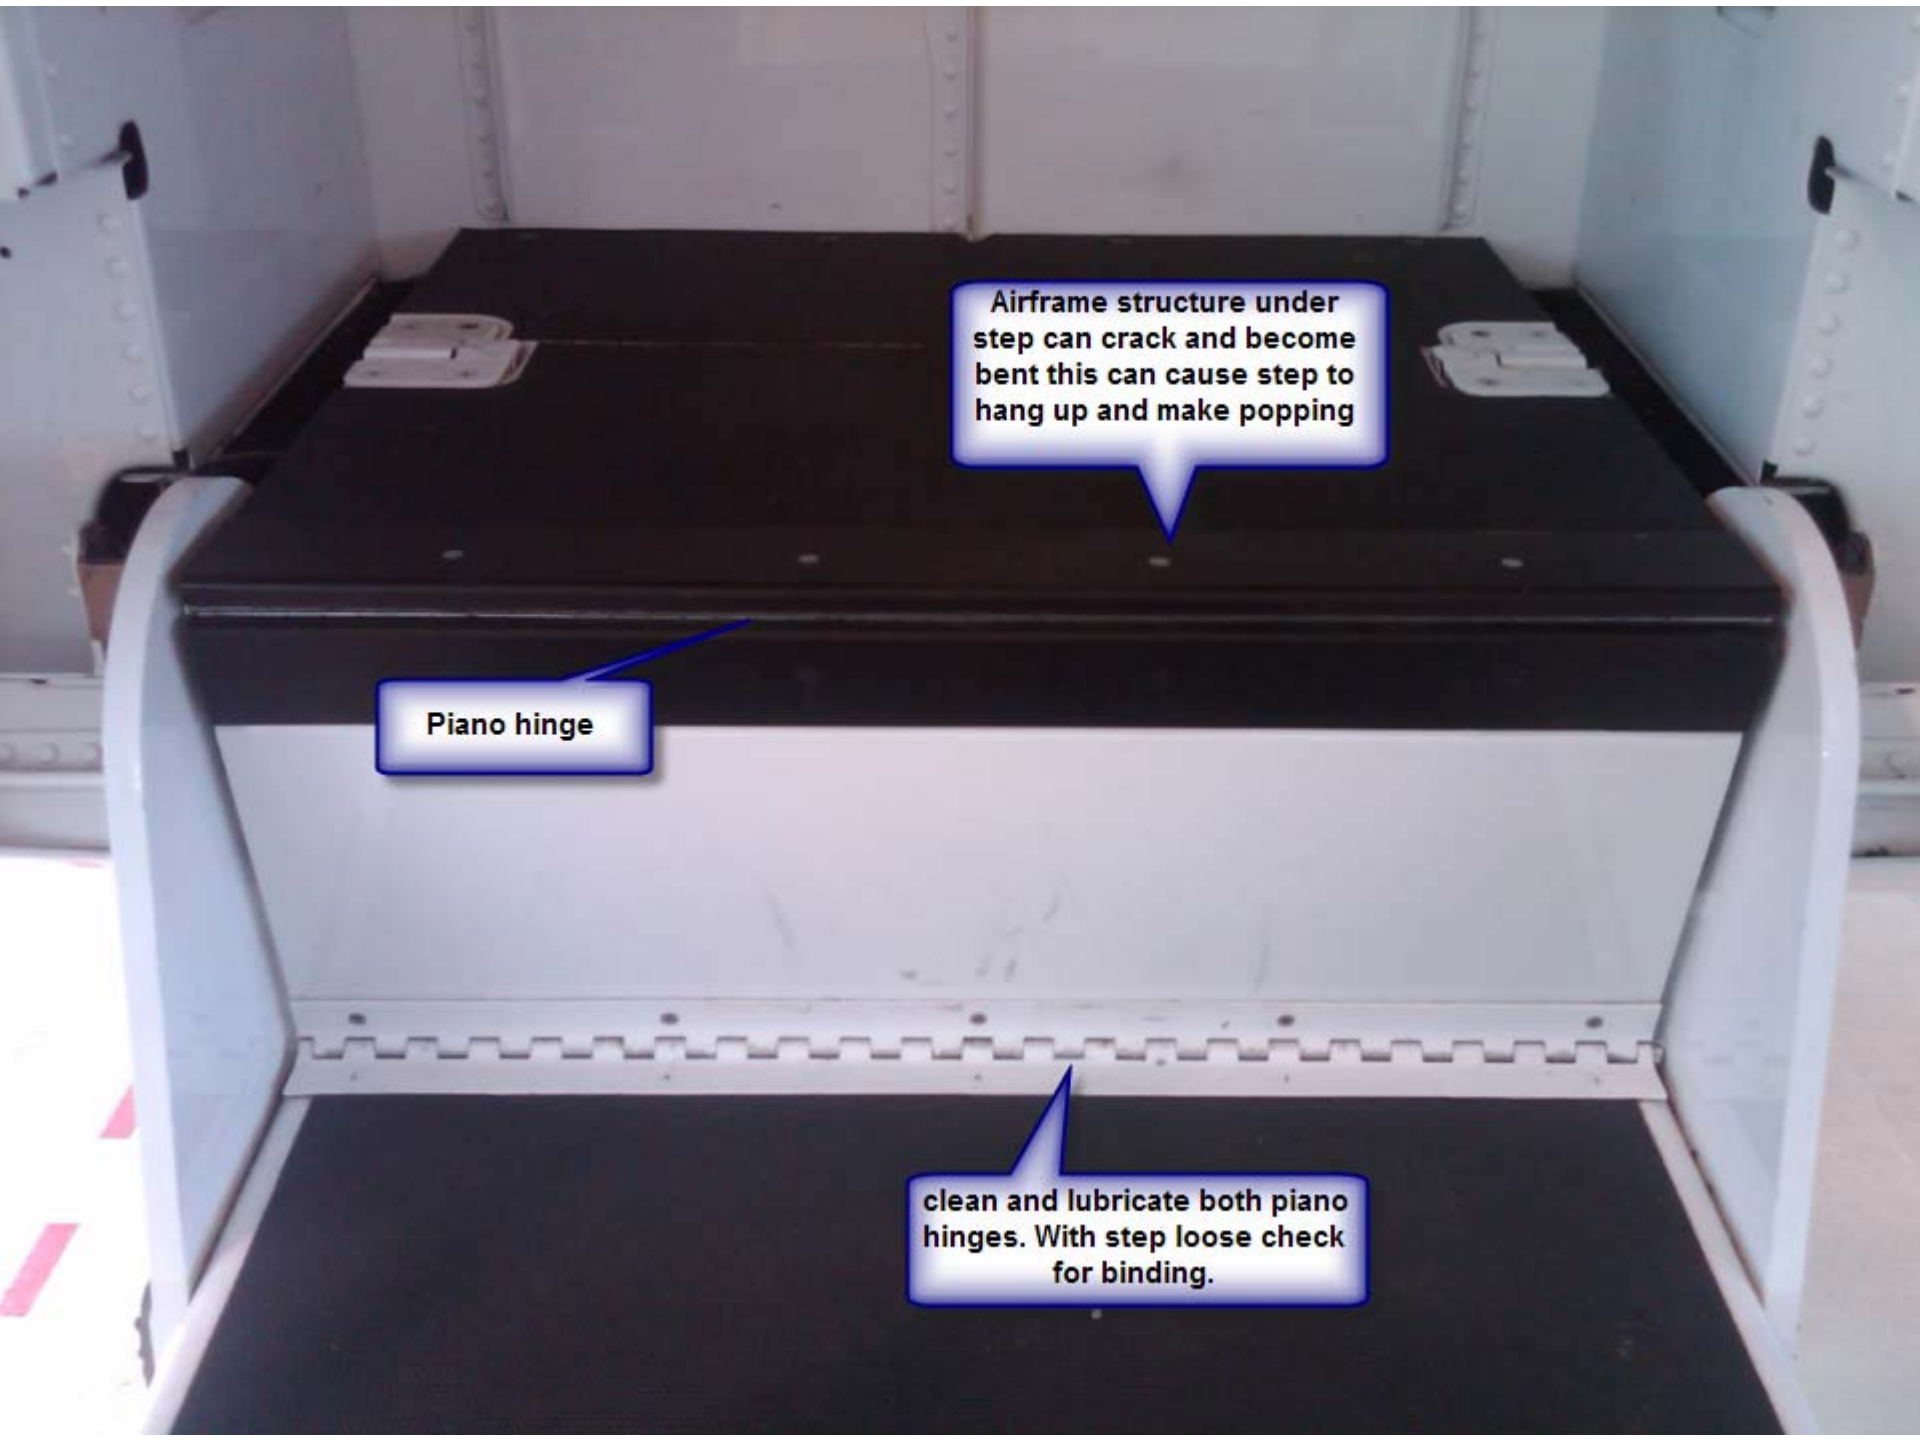
Airframe structure under step can crack and become bent this can cause step to hang up and make popping

Piano hinge

clean and lubricate both piano hinges. With step loose check for binding.

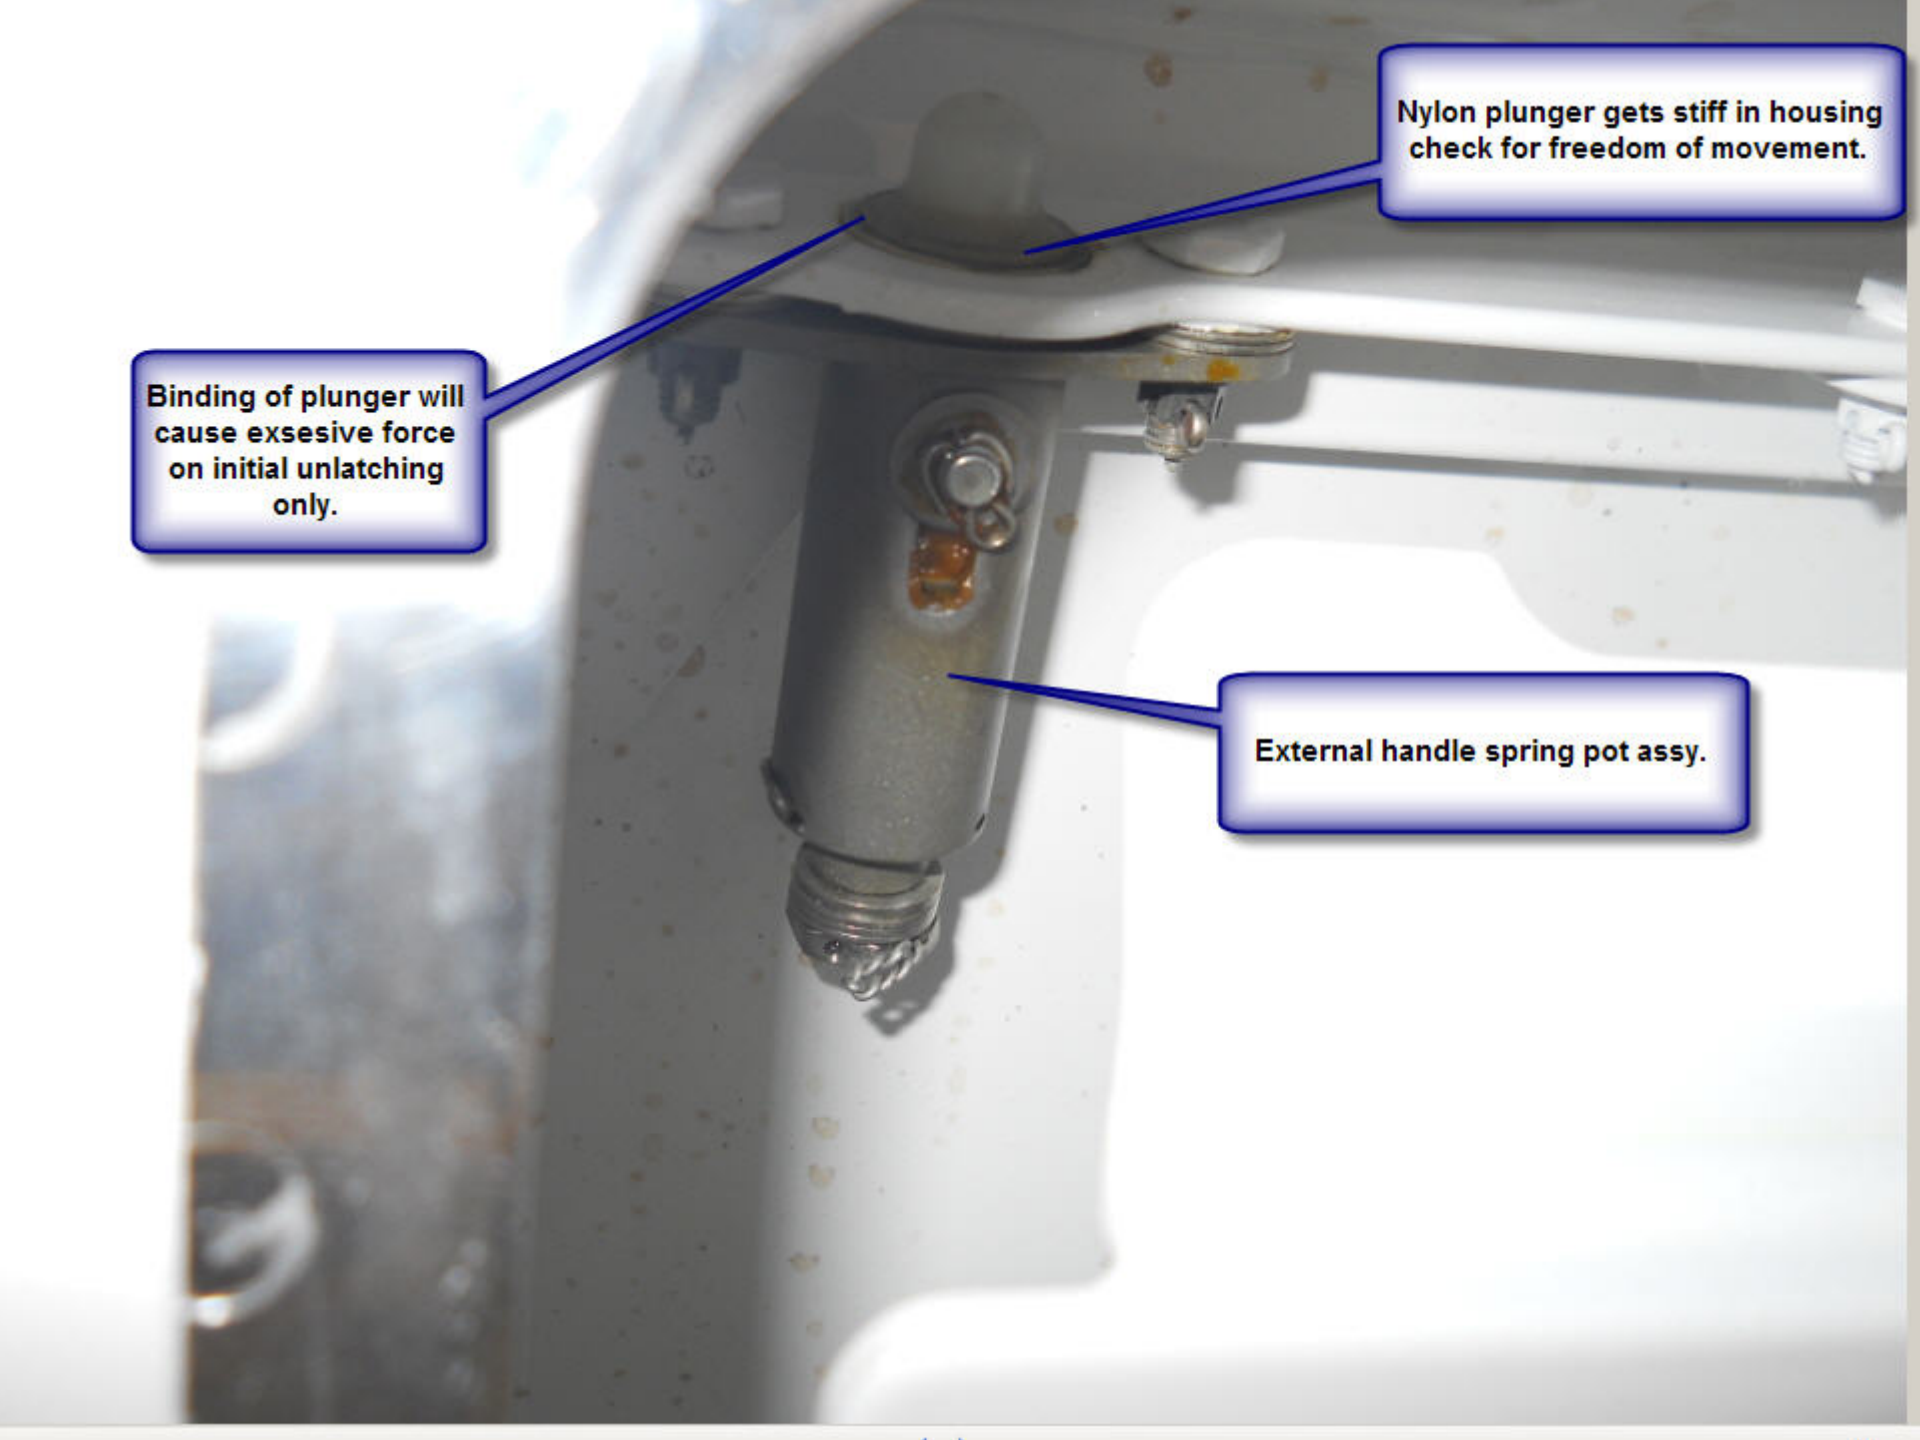
Nylon plunger gets stiff in housing check for freedom of movement.

Binding of plunger will cause excessive force on initial unlatching only.

External handle spring pot assy.

- Door external or internal handle unlatching forces too high
- Check external handle spring pot---check for binding and freedom of movement—Check rig per AMM 52-11-11. Correctly rigged plunger adds approx 5 lbs of force. This is only in effect on the initial unlatching stage. SB installs new style plunger not nylon.
- Lightly lubricate snail fittings on door and airstair.
- Replace large spring pot inside door. This assy helps lighten the door hence lowering the lifting force. Ref AMM 52-11-01-720-801.
- Check small spring pot inside door adjacent to g locks for proper rig. Adds force to detents in torque tube.
- Check vent flap rig—see vent flap page. This is only in effect on the initial unlatching stage

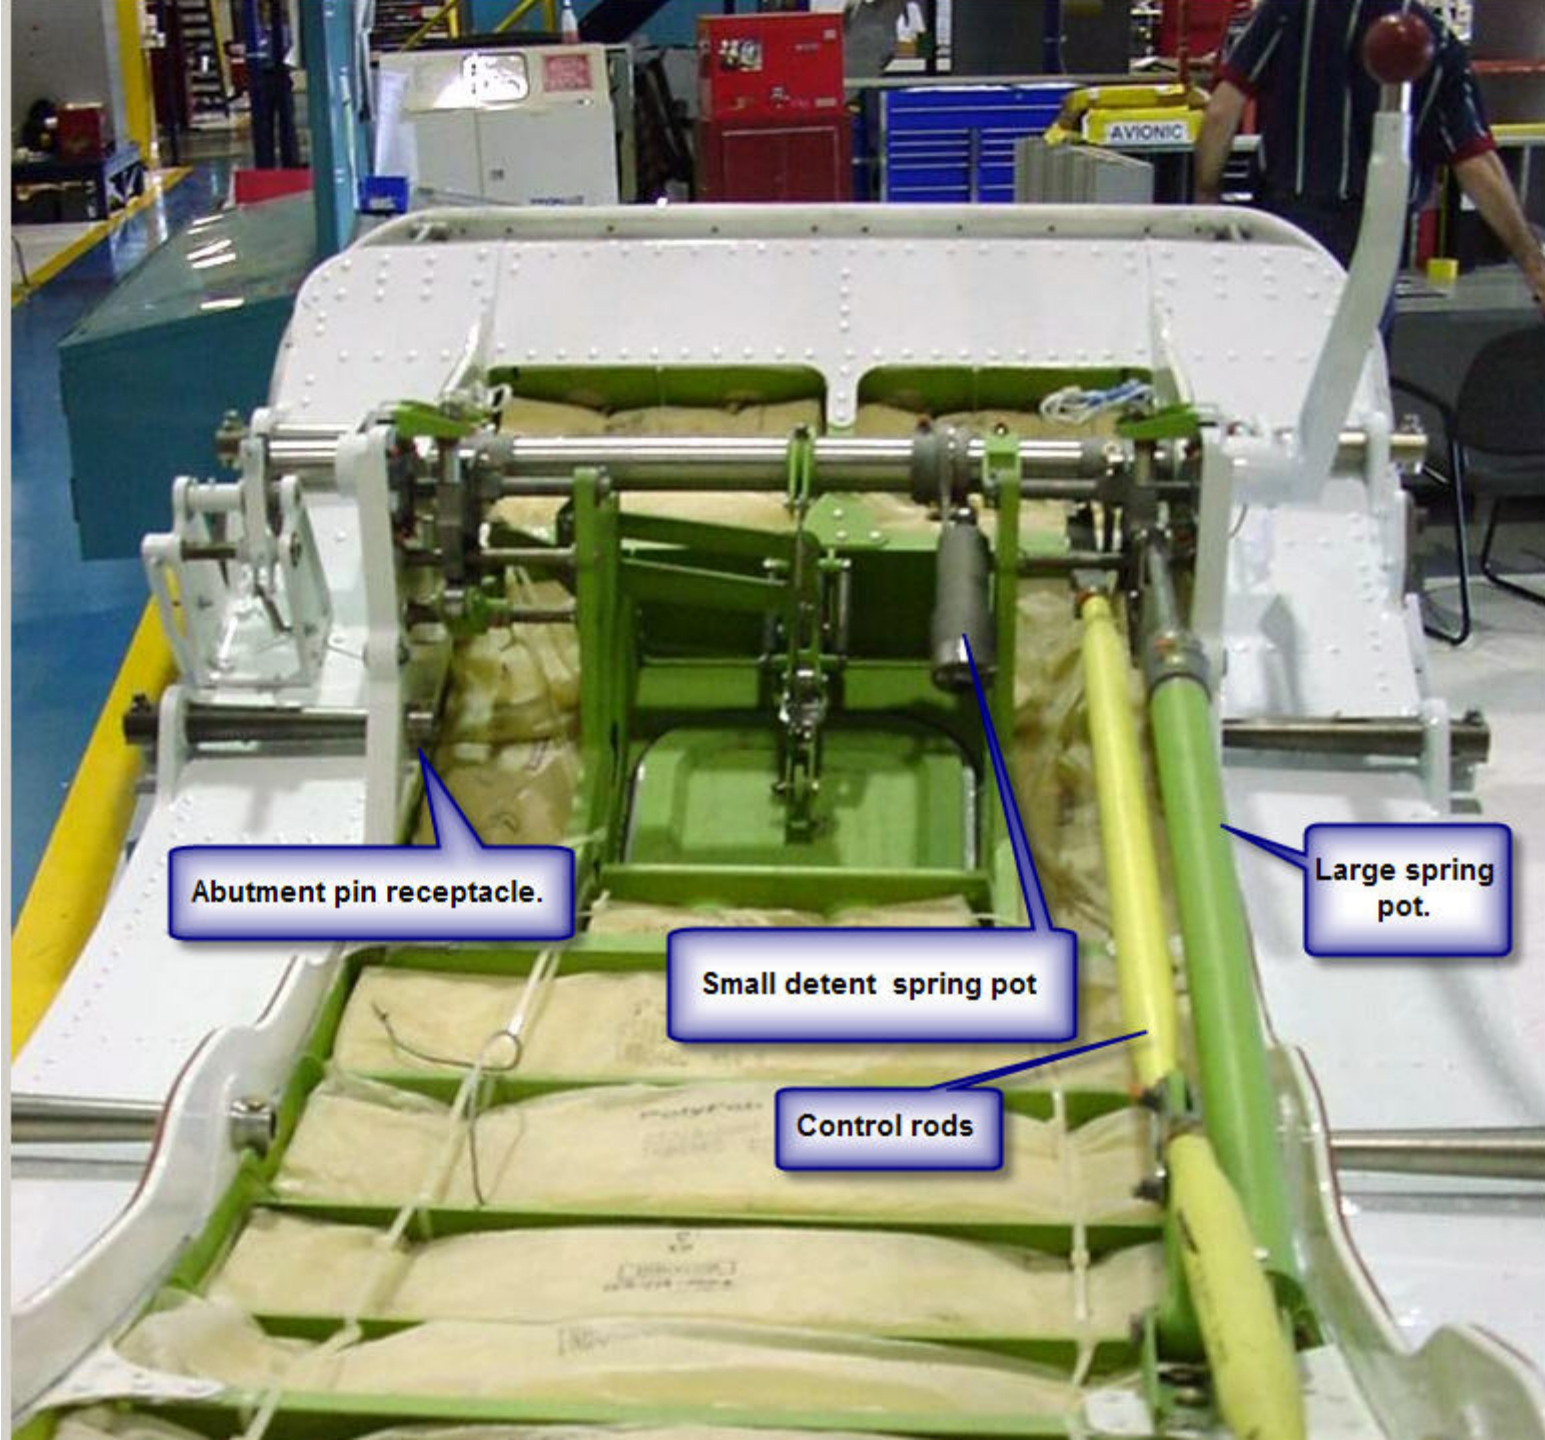
Abutment pin receptacle.

Small detent spring pot

Control rods

Large spring pot.

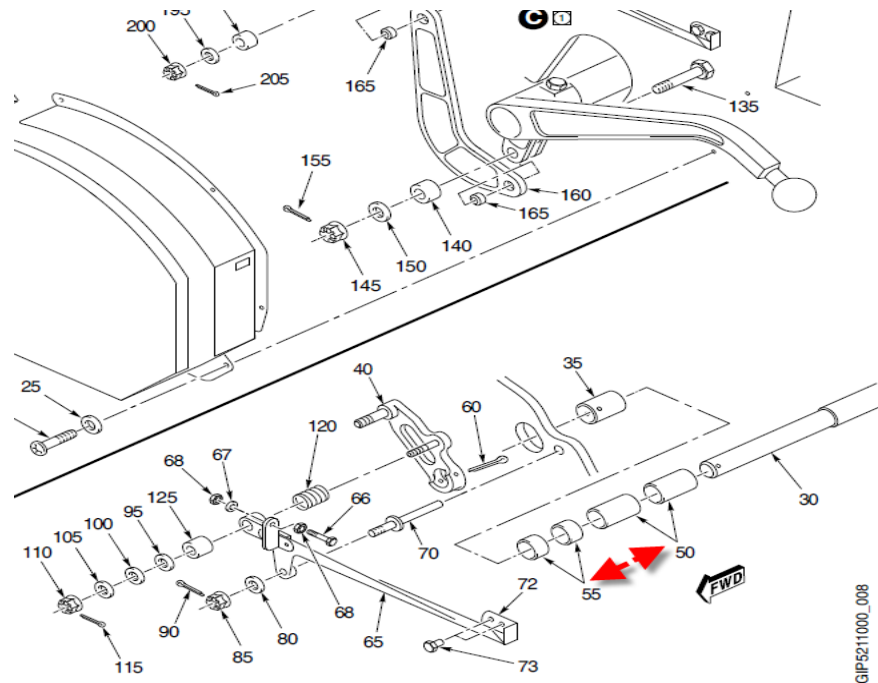
Passenger Door Assembly
Figure 2 (Sheet 2 of 5)

- If excessive play (bounce or rocking) is found between door and airstair with door open adjacent to lower step—check that special rollers and spacers on roller pin which is removed when airstairs are split are correctly installed. Larger diameter rollers should be on outside.
