MODEL BD-100-1A10 (CL-300)

ATA 28-11

**REWORK – WING TANK – ADDITION OF SEALANT TO FACILITATE
WATER DRAINAGE FROM WING FUEL TANKS AND
PREVENT ERRATIC FUEL INDICATIONS**

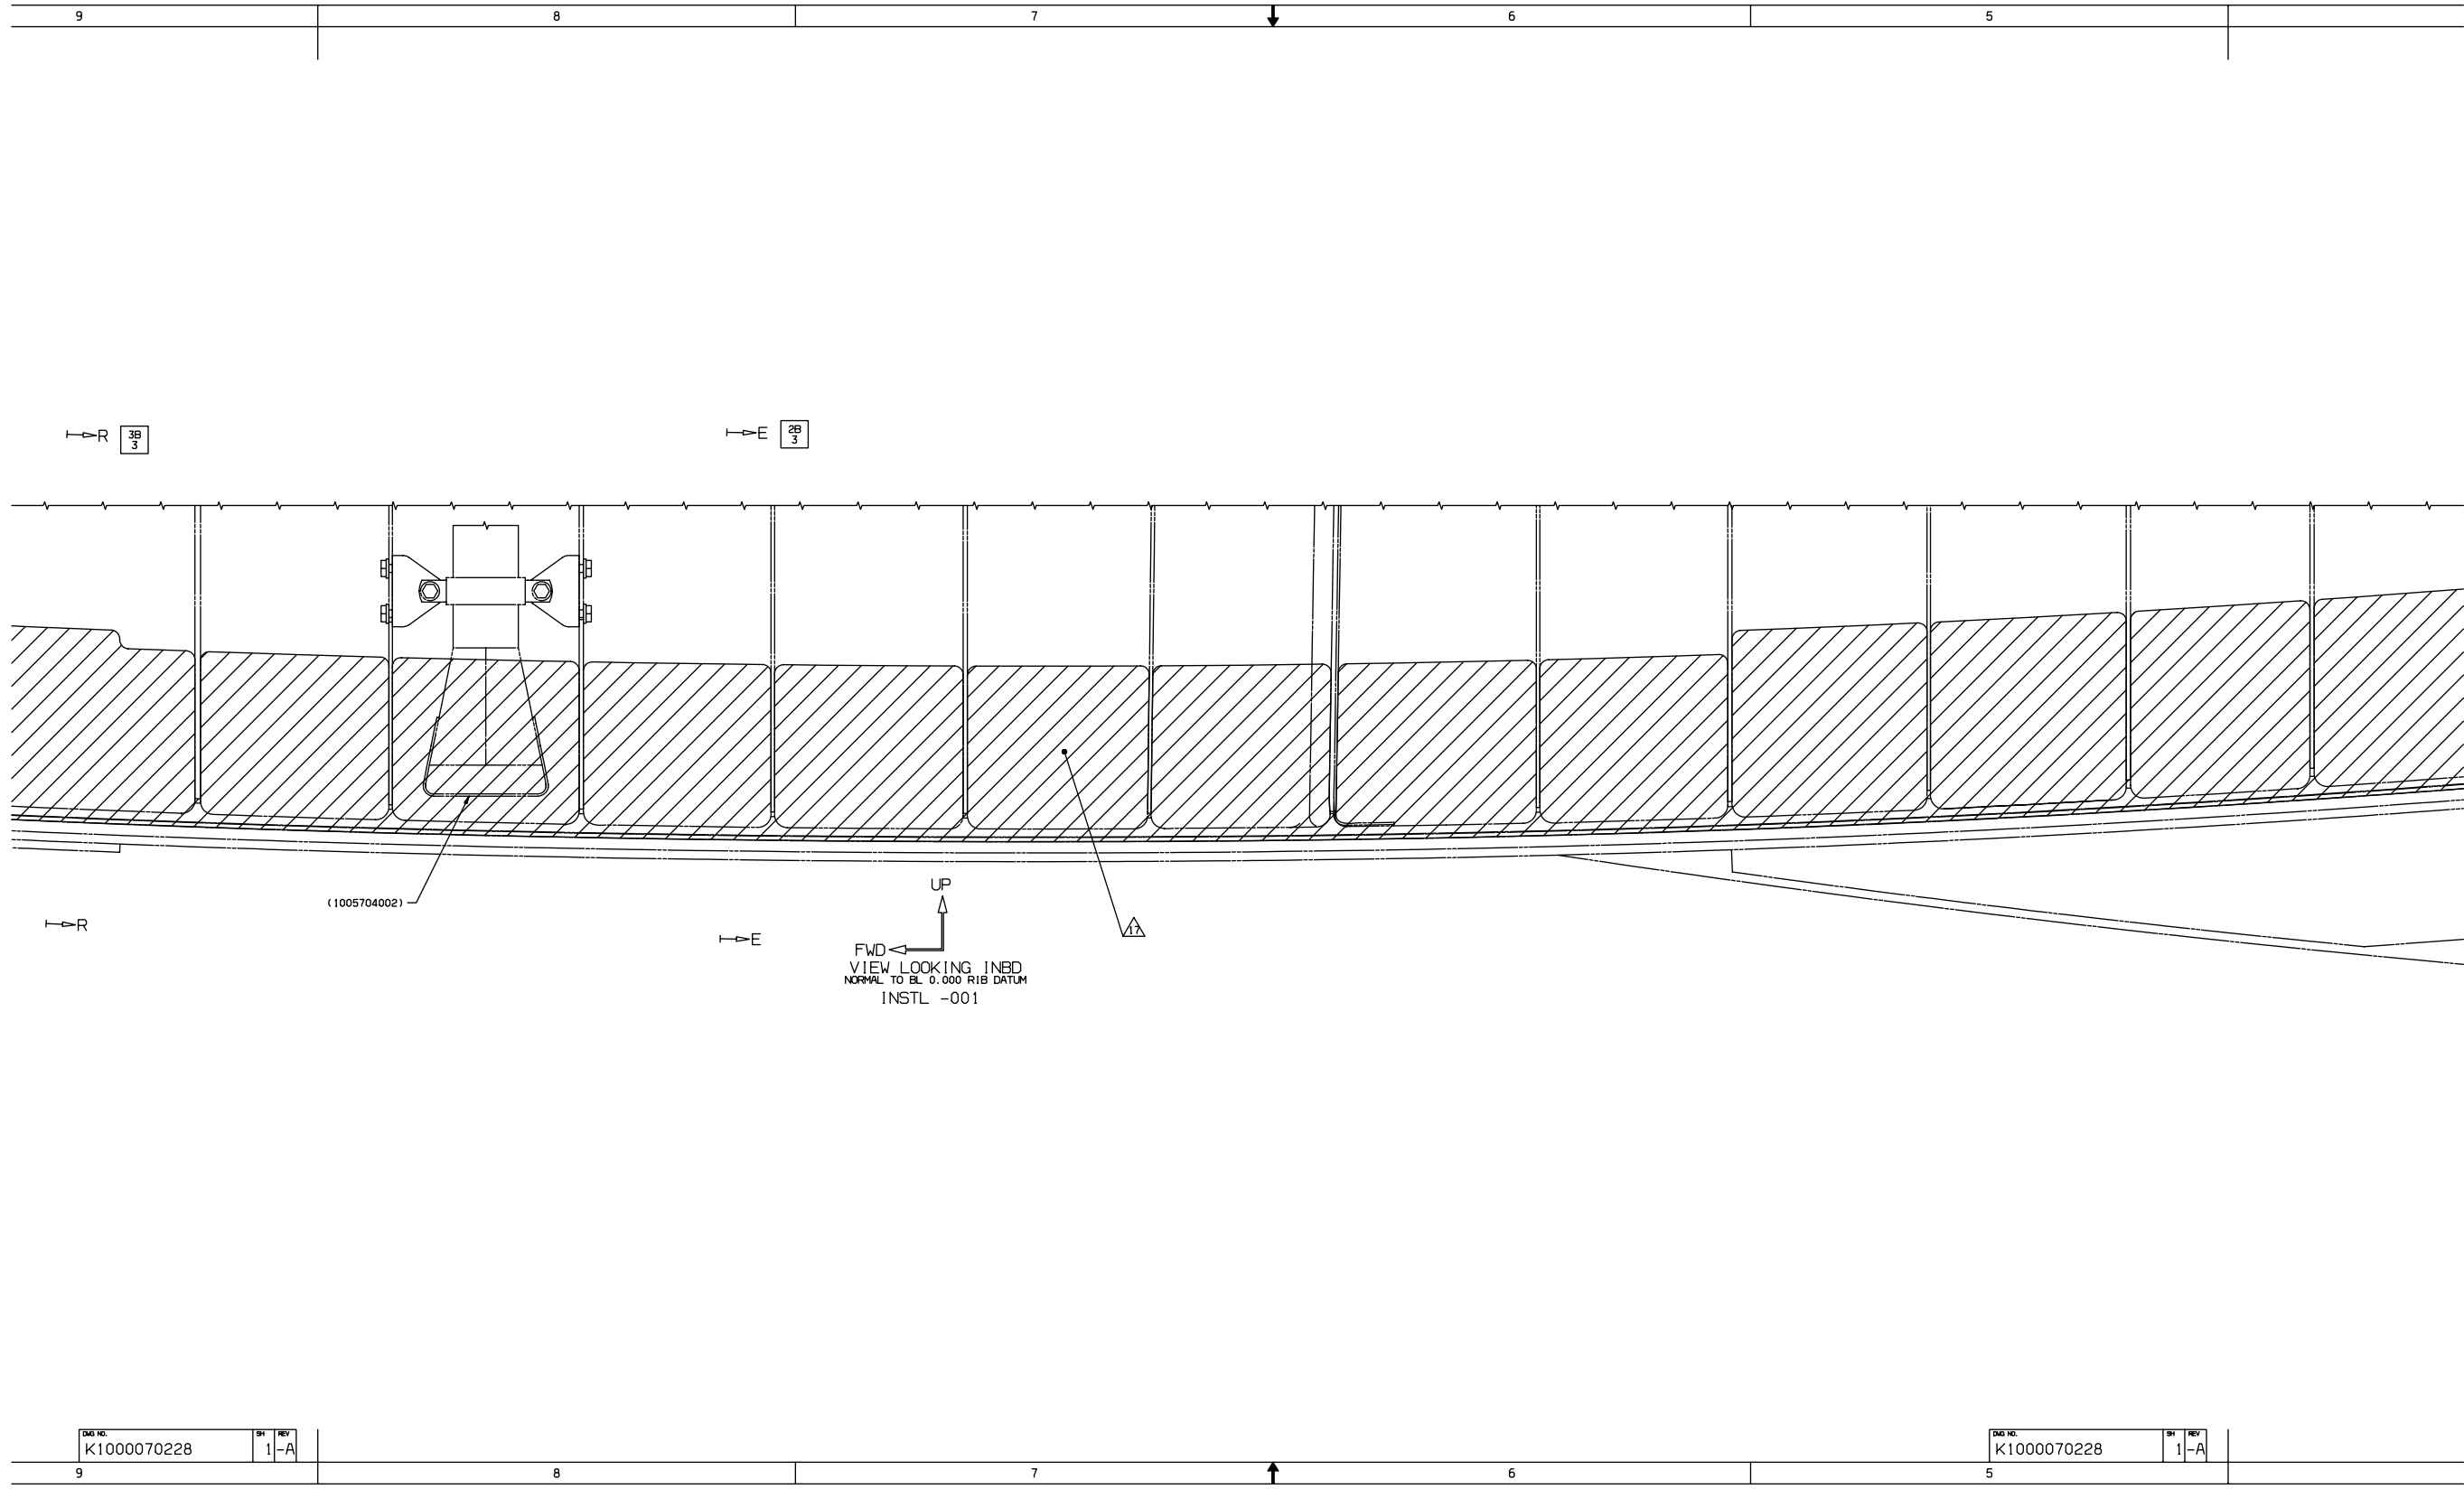
K1000070228 – Kit – Fuel Tank Thermal Sealant Rework BL 0.00
(Sheet 1 of 3, Rev. A)

- THOROUGHLY VACUUM AND CLEAN REWORKED AREAS AS PER BAPS 180-009 (BD-100 AMM CHAPTER 51-25-00).
 - INSPECT REMAINING SEALANT FOR DAMAGE AND GOOD ADHESION TO STRUCTURE. NO GAPS OR VOIDS BETWEEN SEALANT AND STRUCTURE PERMITTED. REPAIR IF REQUIRED.

- IF ANY SEALANT IS REMOVED FROM BL 0.0 SPLICE EDGES RE-APPLY PER: BD-100 SRM CHAPTER 51-23-00
 - IF SEALANT IS DAMAGED OVER ANY FASTENER OR SKIN SPLICE IT SHALL BE REPAIRED PER BD-100 AMM CHAPTER 51-23-00 WITH MIN .06 THK OVER FASTENER AND MIN .10 THK AT FASTENER BASE AND AROUND WASHER

- INSPECT REWORKED AREAS FOR DAMAGE TO STRUCTURE OR FINISH PRIOR TO RE-APPLYING SEALANT.
- IF STRUCTURE OR FINISH DAMAGE IS PRESENT, CONTACT BA SERVICE ENGINEERING FOR DISPOSITION.
