Customer FORUM & Newsletter

TUESDAY, APRIL 5, 2011

VOLUME 08 / ISSUE 07

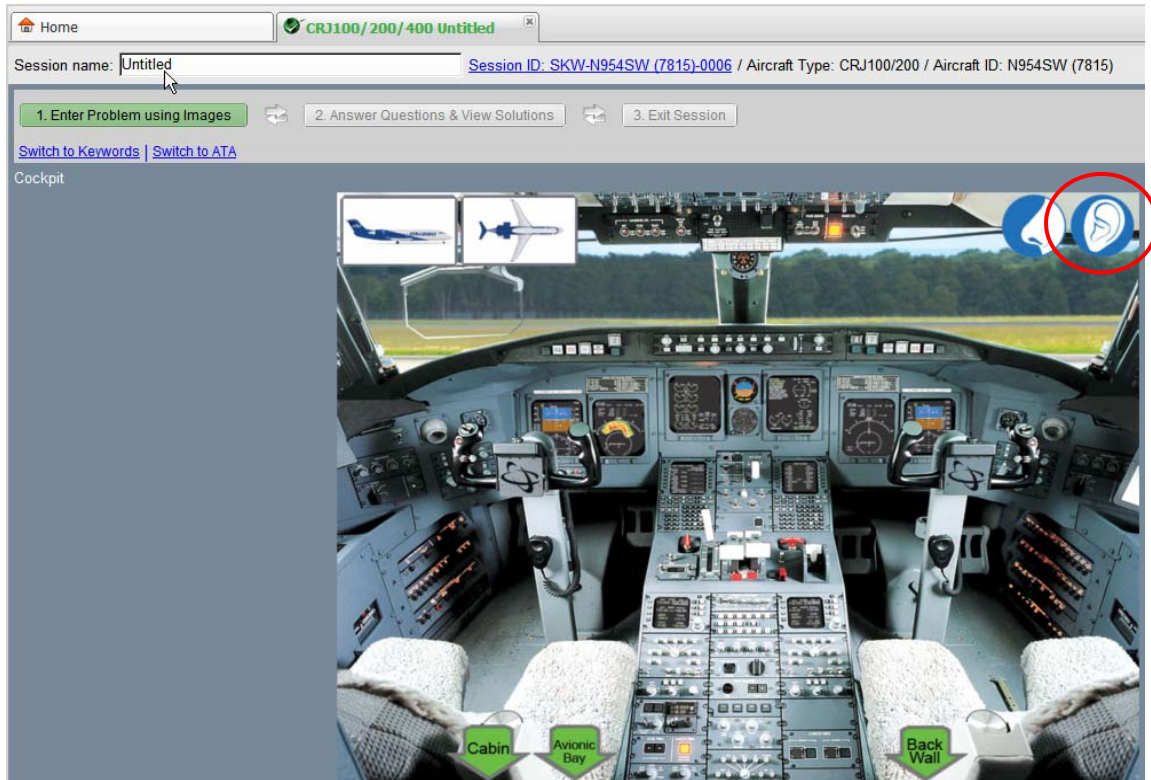
ADS Plus has added features, allowing maintenance to input Squawk details by “ATA,” “Key Words” or “Images.” Selecting Images” brings up the following view:

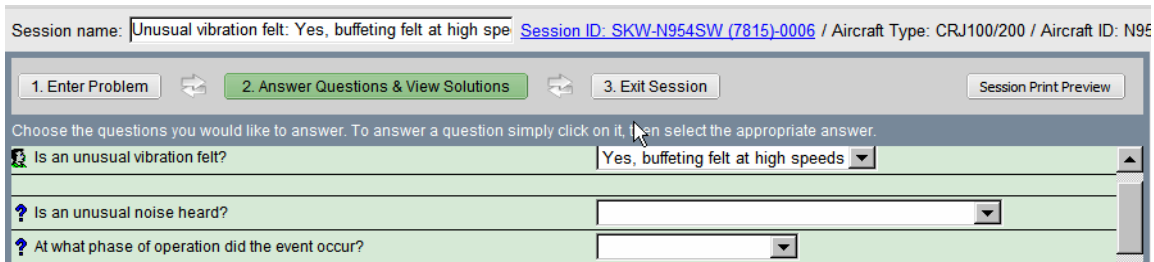
Clicking on the ear for Abnormal Noises, Vibration or Aural Warnings brings up the following questions:

One question seems relevant right away – “Is an unusual vibration felt?” Clicking on the dropdown, the “Yes, buffeting felt at high speeds” is selected.

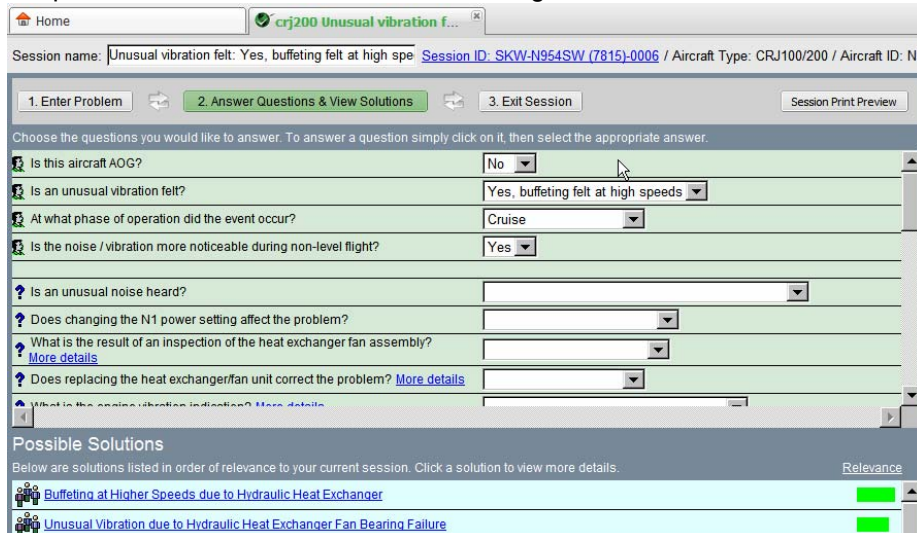
With the initial symptom selected, ADS Plus refines the questions. Maintenance should scan the questions and answer the ones they know. The ADS Session is updated, and the “Possible Solutions” shows significant breakout of two solutions, as shown below:

The top two “Possible Solutions” deal with the Hydraulic Heat Exchanger, which would seem totally unrelated to the Buffeting Problem. This is where ADS excels; the knowledge base uses the symptoms to highlight real world experiences.
