SERVICE INFORMATION LETTER

TITLE: BOMBARDIER CL300

**RAM AIR REGULATING VALVE
PNR 7084A010000**

**RARV TESTING PROCEDURES FOLLOWING “PACK COOL
AIR FAIL” EICAS MESSAGE**

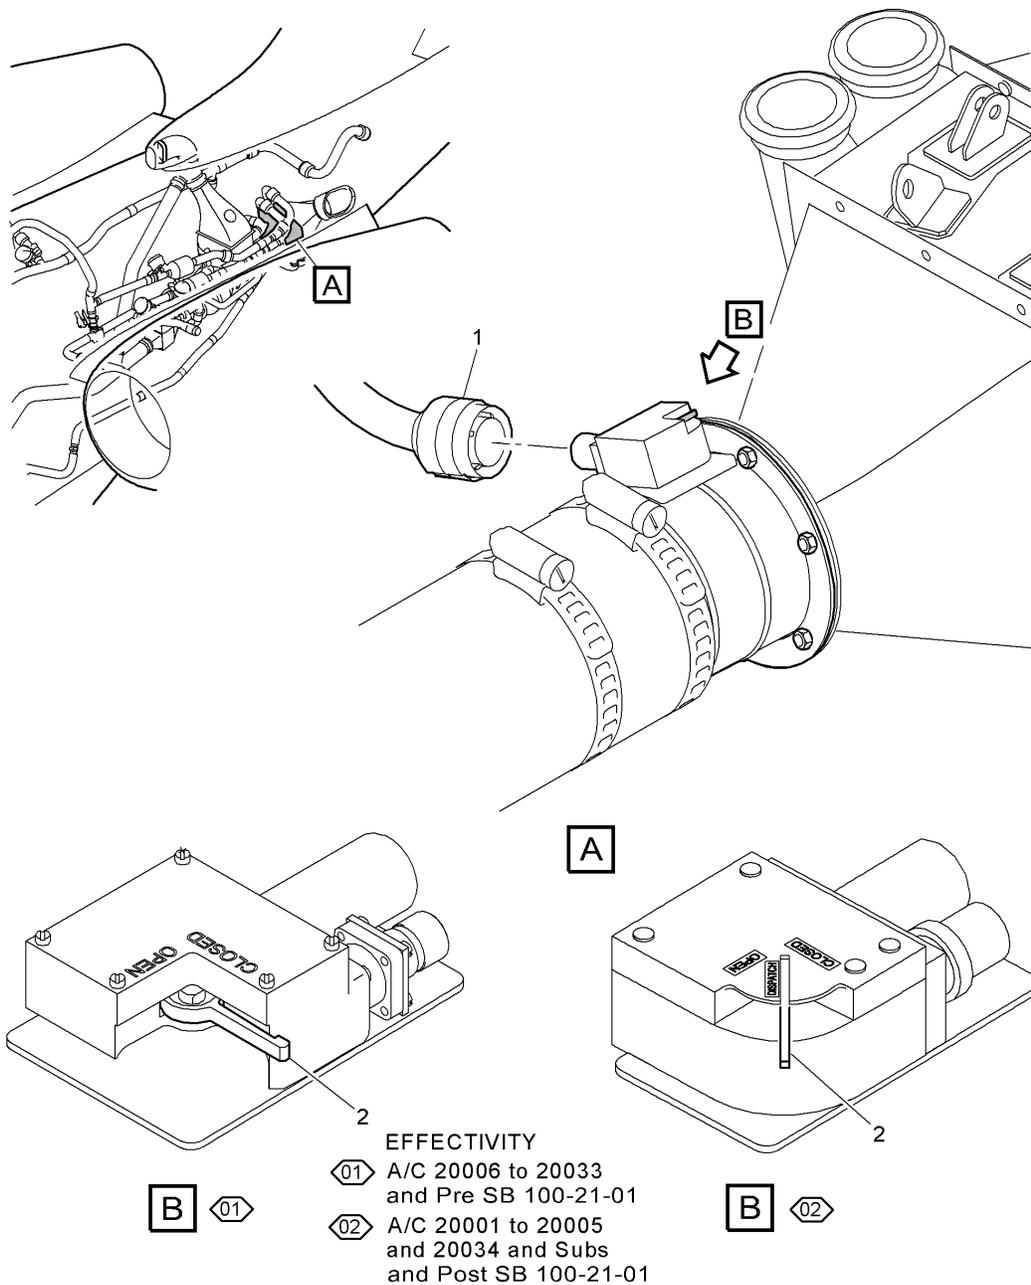
The RARV is installed between the pack and the PCE. The upstream end of the RARV has a beaded end type flange and is connected to the plenum of the pack with a flexible sleeve. The downstream end of the RARV has a flange and is installed on the inlet header of the PCE with six bolts. The body of the RARV is made of aluminium alloy and has a 6 inch inside diameter. The RARV has a 5.1 inch diameter butterfly valve. The diameter of the butterfly valve is smaller than the inside diameter of the RARV body. This difference in diameter is necessary to make sure that there is ram airflow through the DHX and the PCE at all time. An electrical actuator (28 V dc) controls the butterfly valve. Two microswitches monitor the Full Closed and Full Open positions. The RARV has a manual lever. This manual lever is used to manually operate the butterfly valve during maintenance of the RARV.

The manual lever can also be used to temporarily deactivate the RARV when necessary:
