# infoservice

ISSUE NO. 1

Global Express

DECEMBER 1999

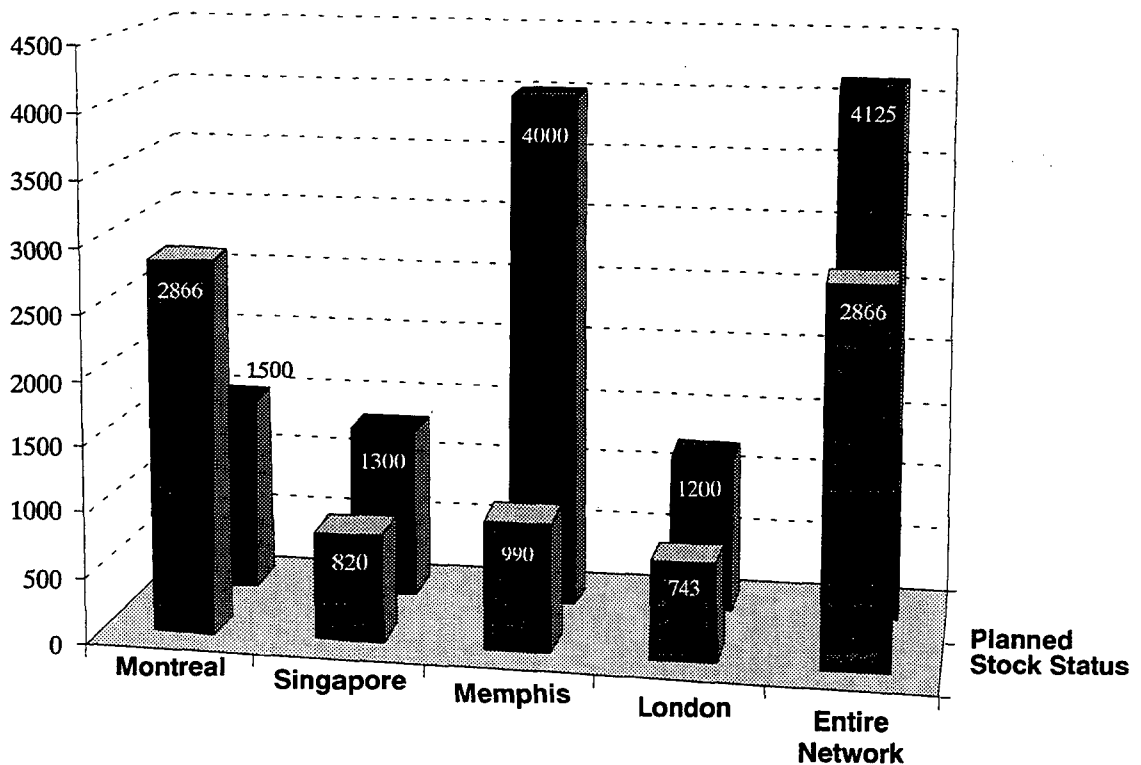
The following chart depicts the status of the planned inventory, per part number, against the target levels for each Distribution Center and the entire network.
