Advisory Wire

REFERENCE NO:	AW300-44-0404	INFORMATION TYPE:	Maintenance
ATA:	44-00	EFFECTIVITY:	Challenger 350
SUBJECT:	Wireless charging guidance

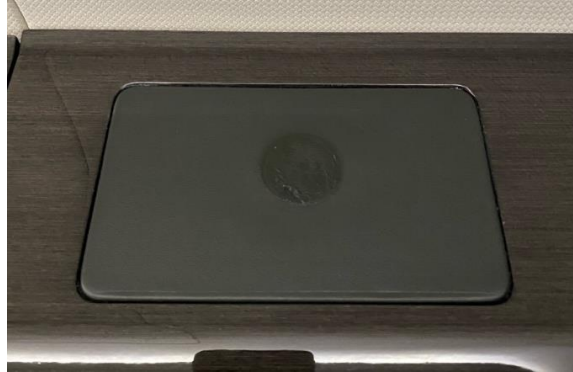
Bombardier Technical Services was informed of a recent event where a smartphone with a metal ring holder mounted on it (Fig. 2) was placed on a wireless charging pad (Fig. 1). The Foreign Object Detection of the wireless charger was not able to detect the ring holder and the charging process was initiated. The ring holder was subjected to the electromagnetic field, and it began to heat up. The ring holder left a mark on the wireless charging cover (Fig. 1).

Fig 1 - Charging pad cover

Bombardier and Lufthansa Technik (Ref 1.1) would like to recommend that all metal add-ons (case, ring holder, etc.) on a smartphone be removed when using a wireless charging pad. Smartphones should be in direct contact with the wireless charger cover to avoid causing heat damages to the surface of the charging pad cover-

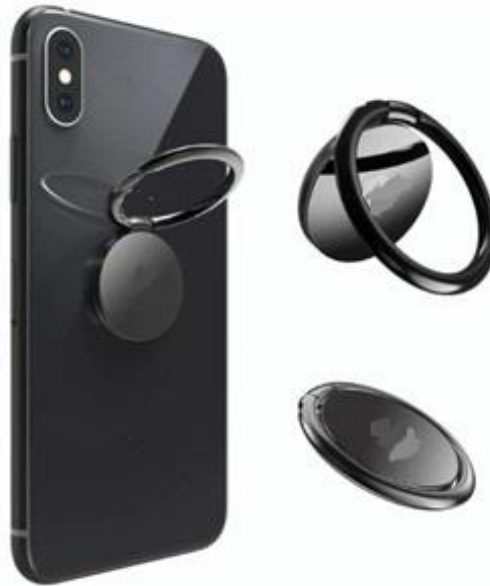
Fig. 2 - Ring holder
