Advisory Wire

REFERENCE NO: AW300-72-0348

SUBJECT: AS907 Engine Diffuser Seal and Anti-Ice Valve

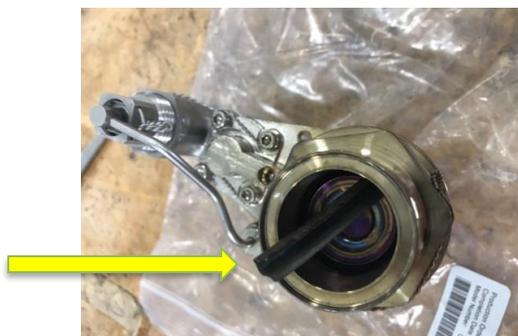
Operators should be aware of an issue that has been discovered with diffuser seal failures. There is a possibility that remnants of the seal may break away and make their way to the CAIV or WAIV. These remnants may prevent the valve to close correctly.

Example of diffuser seal found in the WAIV

When removing an engine due to the failure of the diffuser seal it is important to ensure that the CAIV & WAIV and all associated ducting is inspected to ensure that no debris is present in the system.
